# PROPOSED HYPOTHESIS, TESTING AND DOCUMENTATION, AND ACTIONS TO BE TAKEN FOR THE CONSERVATION OF THE SPHINX

*John P. GNAEDINGER*

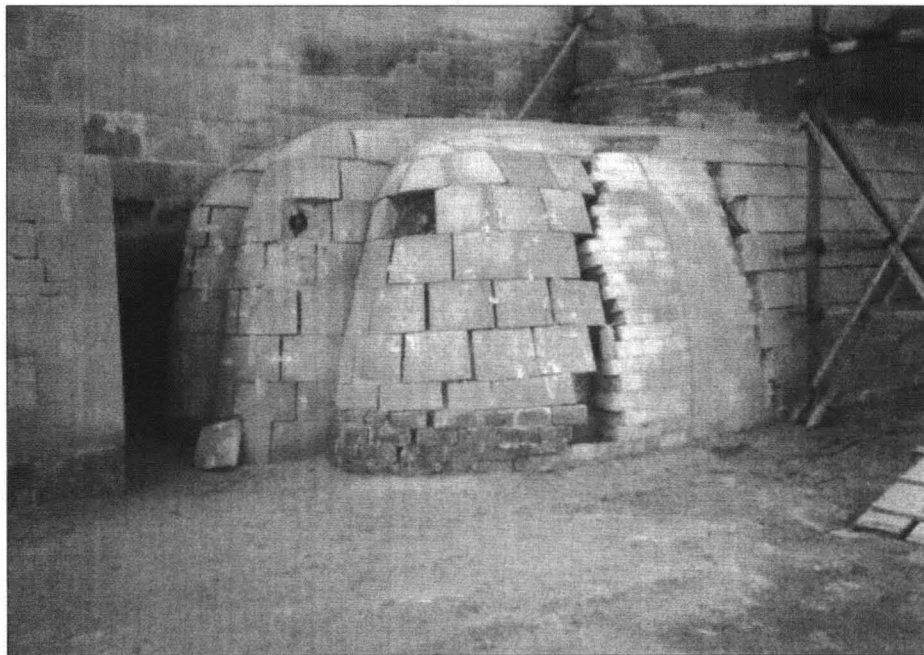
Recognizing this failure, a decision was made to replace the concrete block and mortar with limestone blocks and lime mortar (Fig. 2), on the presumption that it was the original mortar that was causing the problems rather than recognizing that the problem was originating with the rehydration of anhydrous gypsum within the mass of the Sphinx.

Fig. 2. Limestone blocks covering the Sphinx.

It is the author's opinion that the net effect of the concrete block or limestone block, in either case, is to minimize evaporation, and therefore maximize the rehydration of many thousands of years of accumulation of anhydrous gypsum that has formed within the mass of the Sphinx since it was built.

It could thus be predicted that, with the present plating of limestone blocks, while it may take a century or two to deteriorate, the ultimate result will be the total destruction of the Sphinx by progressive deterioration due to rehydration of gypsum, and perhaps other salts.

However, the process is greatly accelerated by the limestone covering of the Sphinx. In the short term, of course, even though it changes the texture of the Sphinx from its original nature, the Sphinx as a monument can appear to have a much more stable and attractive appearance than it would if the limestone were not being placed, but the benefit is clearly temporary.

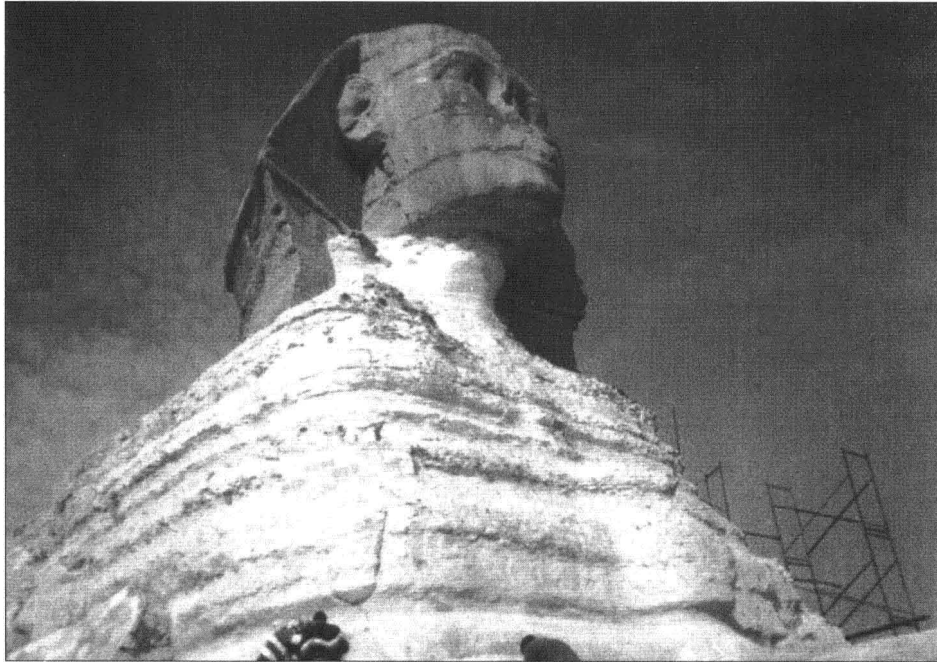
There appears to be differences of opinion as to where the head of the Sphinx is on the verge of falling forward, due to deterioration of weaker limestone in the neck, or whether it is stable, at least for the foreseeable future (Figs 3-4).

Fig. 3. View showing the weaker limestone in the neck.

However, epoxy-mounting of simple, inexpensive geophones at several locations on the head and neck of the Sphinx would provide useful data concerning the state of stress in the neck in a matter of weeks after a decision is made to proceed. A simple, signal amplifier and sequential recorder, all equipment costing less than \$ 10,000, are all that is necessary, plus geophones, ladders, and a tube of epoxy.

Lest the authorities be accused of 'fiddling while Rome burns', a plan should be implemented for actions to be taken immediately. The obvious action would appear to be the installation of several rock anchors, placed in holes carefully drilled from the top of the head, slightly sloping toward the head of the Sphinx, and well into the body. Stainless steel anchors, threaded at the top, would be anchored in the holes using Roc-Loc, and tension added and locked in with appropriate components at the top. Strain gages and sonic data should be taken to verify that the designed measures are achieved and maintained forever.

Perhaps a later program could reconstruct the beard that originally is said to have existed on the neck, using it to further stabilize the head of the Sphinx.

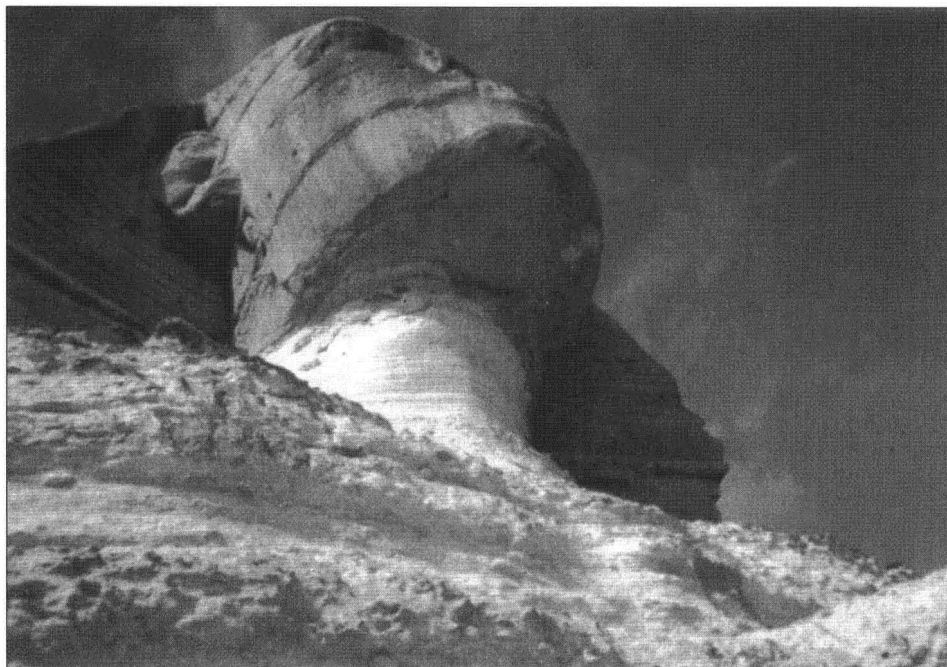
Fig. 4. Closer view of the weaker limestone in the neck.
