# THE PASSAGE UNDER THE SPHINX\*

Zahi HAWASS and Mark LEHNER

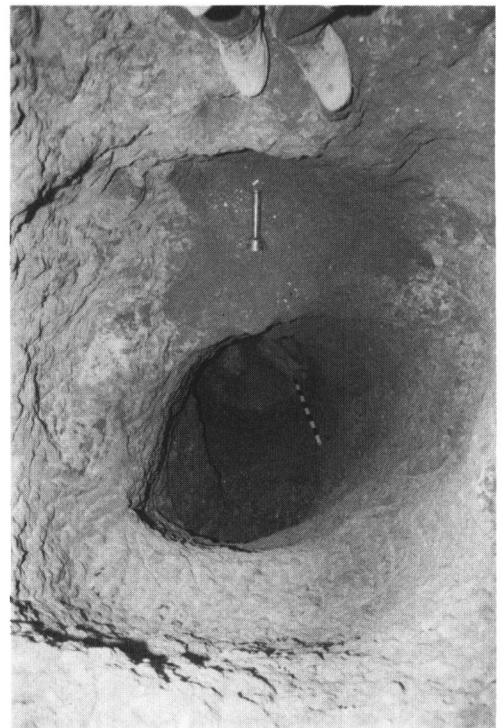
Fig. 3. - BW 18: 15  
Sphinx, NW, Rump passage (fcl), looking down  
Chambers 3 and 4; rubble fill cleared from  
Ch. 4, water beginning to infiltrate. 12/x/80.

*Area 3:* The bottom of Area 2 opens onto the shaft leading down below the floor level of the Sphinx. Area 3 ends at a 0.85 m-wide ledge 2.08 m. below the ledge at the bottom of Area 2 and 2.76 m. below floor-level [fig. 3]. The passage is 1.22 m. wide at the bottom of Area 3.

5. The backs and underside of the Phase I blocks are not damaged but have an occasional residue mortar, limestone chip, sand and clay packing.
6. The limestone pieces on the ledge of Area 1 are solid in their position and may be mortared to the floor of the passage [fig. 3].

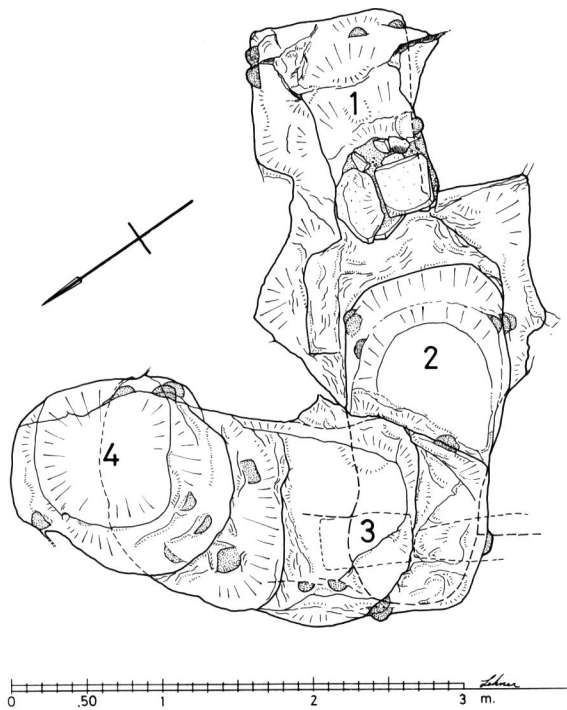
Fig. 4

On October 16, 1980, we moved this single small slab to expose a grey cement packing characteristic of Baraize's repairs on the Sphinx. We forced a small hole through this packing and found that the bedrock floor dropped off into a cavity immediately under the brick-sized veneer masonry that Baraize had replaced [fig. 2, 6]. Behind the brick-sized and cement/limestone packing Baraize had set a large limestone slab to bridge the opening of the passage. We removed the bridging slab to allow easier access. Behind it were two larger slabs set end to end to bridge the opening [fig. 4, 5, 6, a view of the covering of the passage looking up].

The passage consists of an upper and lower part that lie roughly 90 degrees to one another [fig. 1, 4]. The lower part descends from a circular hole in the floor where it meets the rise of the bedrock core body. It slopes downward at a very steep angle toward the northeast, for a distance of 4 m. and a depth of 5 m. and terminates in a cul-de-sac in the natural rock [fig. 2, 3]. Just inside the entrance, the passage is 1.30 m. wide and narrows to 1.07 m. near the bottom. The sides of the shaft show long, stroke-like tool marks made with a pointed chisel, and small, half-cup-shaped footholds. We found the bottom of the passage clogged with debris.

We delineated four main areas in the passage for the purposes of description [fig. 2 and 4]: (1) the niche at the top of the upper shaft, (2) the shaft leading up to the niche, (3) the shaft descending immediately from the floor-level entrance, and (4) the cul-de-sac pit at the bottom of the lower part of the passage.

The foothold cuttings appear on all three sides of the niche, two on each side [fig. 2, 4]. As noted, they occur very near to the top of the niche. They measure about 0.10 m.- 0.18 m. in height and width and they are cut to a depth of about 0.10 m.

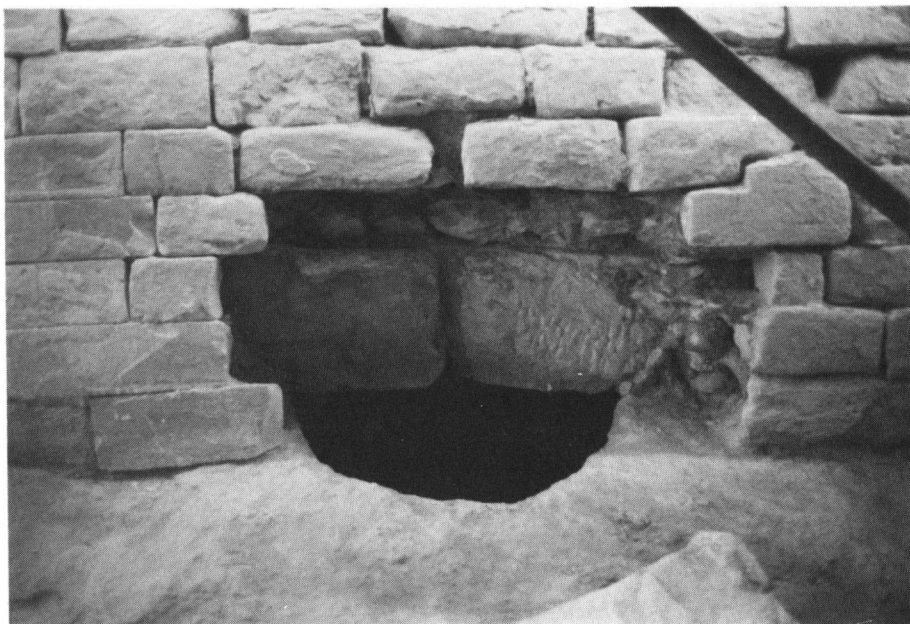
Fig. 6. - BW 17: 9-28  
Sphinx, NW, Rump passage (fcl): opening to passage, modern replacement slabs removed.  
17/ix/80.

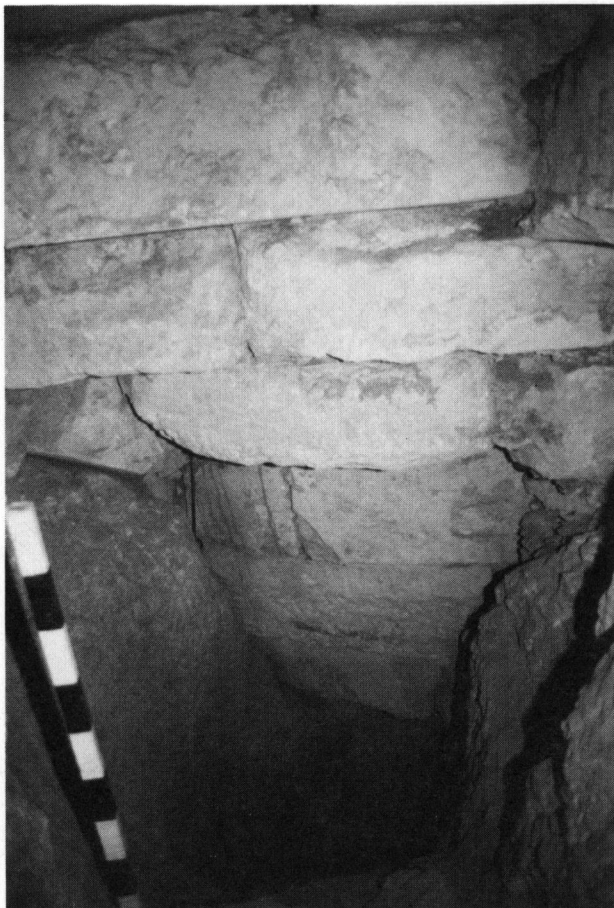
*Fig. 7. - BW 17: 9-28  
Sphinx, NW, Rump passage (fcl): Looking down  
Chamber 2; Phase I masonry abutting to bed-rock core.  
17/ix/80.*

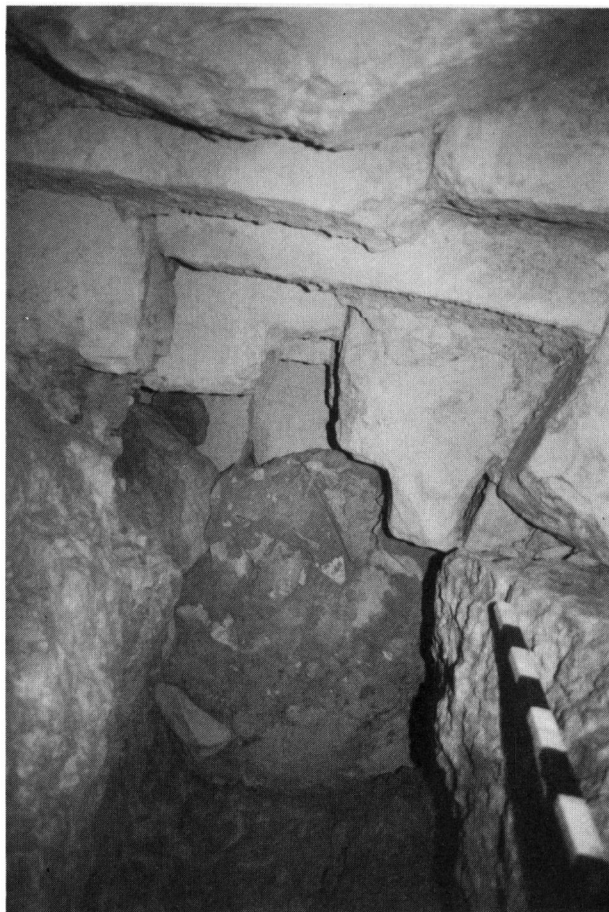
*Fig. 8. - BW 17: 9-28  
Sphinx, NW, Rump passage (fcl): Looking up into  
Chamber 1; Phase I masonry to core and cement (?)  
application at top. 17/ix/80.*

The top of the passage is sealed off by the Phase I blocks and a large patch of modern cement [fig. 2, 8]. Although it is difficult to know for sure, it seems most likely that the Phase I blocks do not entirely seal off the passage. The cement probably spilled down into the passage from the filling of the space between the

*Area 1:* the patch of modern cement at the top of the passage is 0.30 to 0.35 m. thick. It seems to adhere to the underside of the adjacent Phase I blocks at the top of the niche [fig. 2, 4, 8]. The material is a cement or sandy mortar containing limestone fragments, spots of tan clay, and many carbon spots that are probably charcoal. It looks like the same cement mixture that fills the wide space between the Phase I slabs and the bedrock core on the rump ledge 3 m. higher [fig. 1, 2]. The cement patch runs over the bedrock cutting at the upper west end and sides of the niche, except on the south-southeast where a space between the cement layer and the bedrock cutting exposes the Phase I slabs [fig. 5, a view looking upward of the ceiling of the passage]. At the south front corner of the niche, the cement layer rests upon an irregular limestone fragment which in turn rests upon the corner of a protruding Phase I block. Along the west edge of the cement layer (facing into the passage), the cement hangs free on its edges and underside but is attached to the underside of the broad Phase I slabs above it [fig. 5, 8].

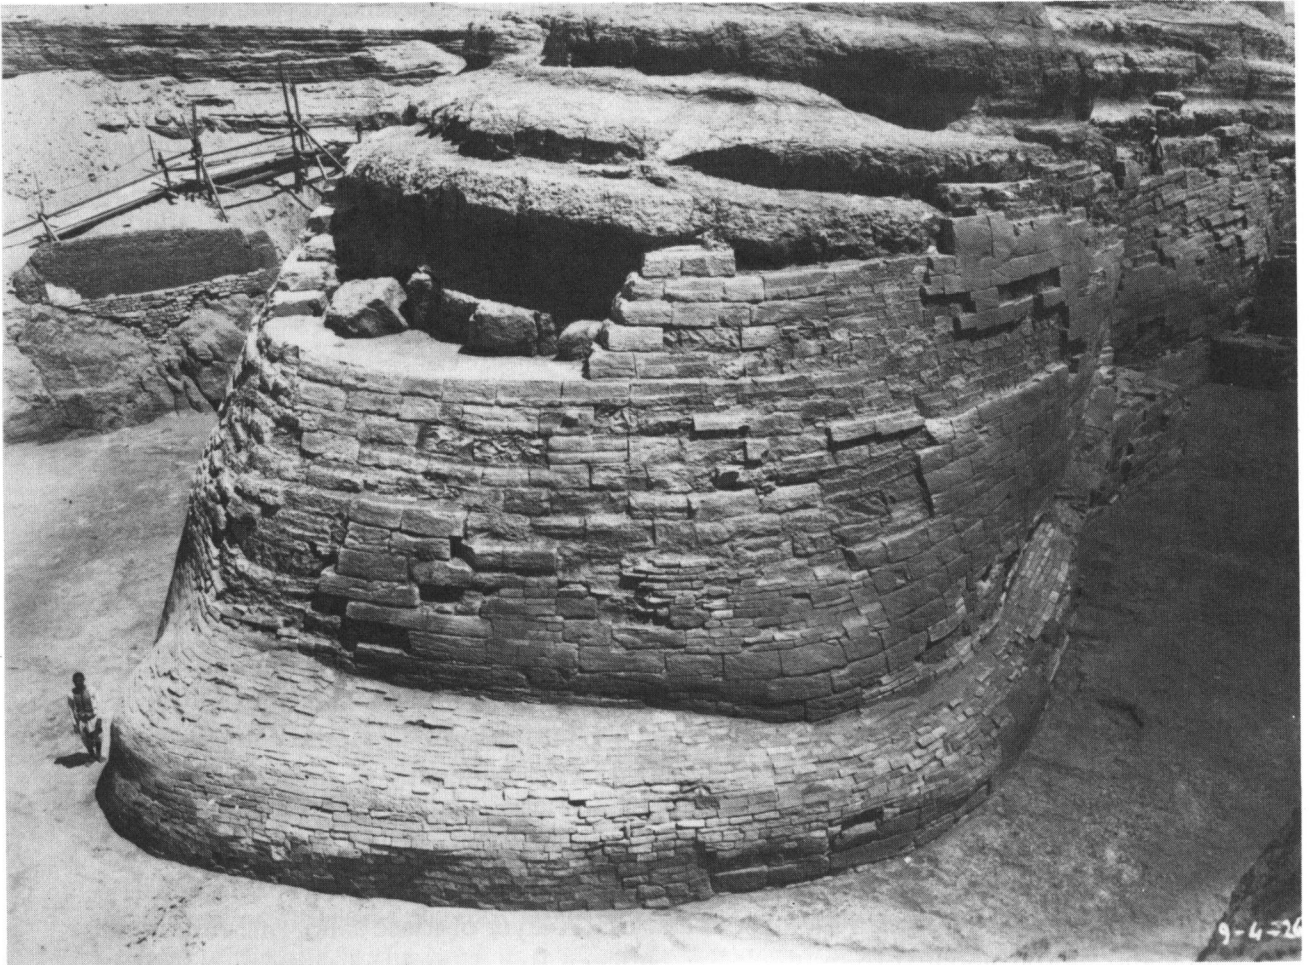
*Fig. 9*

The opening to the passage is at the base of the Sphinx at the north side of the rump just beside the beginning of the tail, about 15 m. from the west side of the north large masonry box [fig. 9, where the man is standing].

3. On the ledge formed by the removal of masonry veneer, three meters almost directly above the top of the passage, a boulder has separated from the core and lies wedged against the back of the Phase I blocks [fig. 1, 9].
