VOLUME XXXIX
2002

The Pyramid Age Settlement of the Southern Mount at Giza

MARK LEHNER

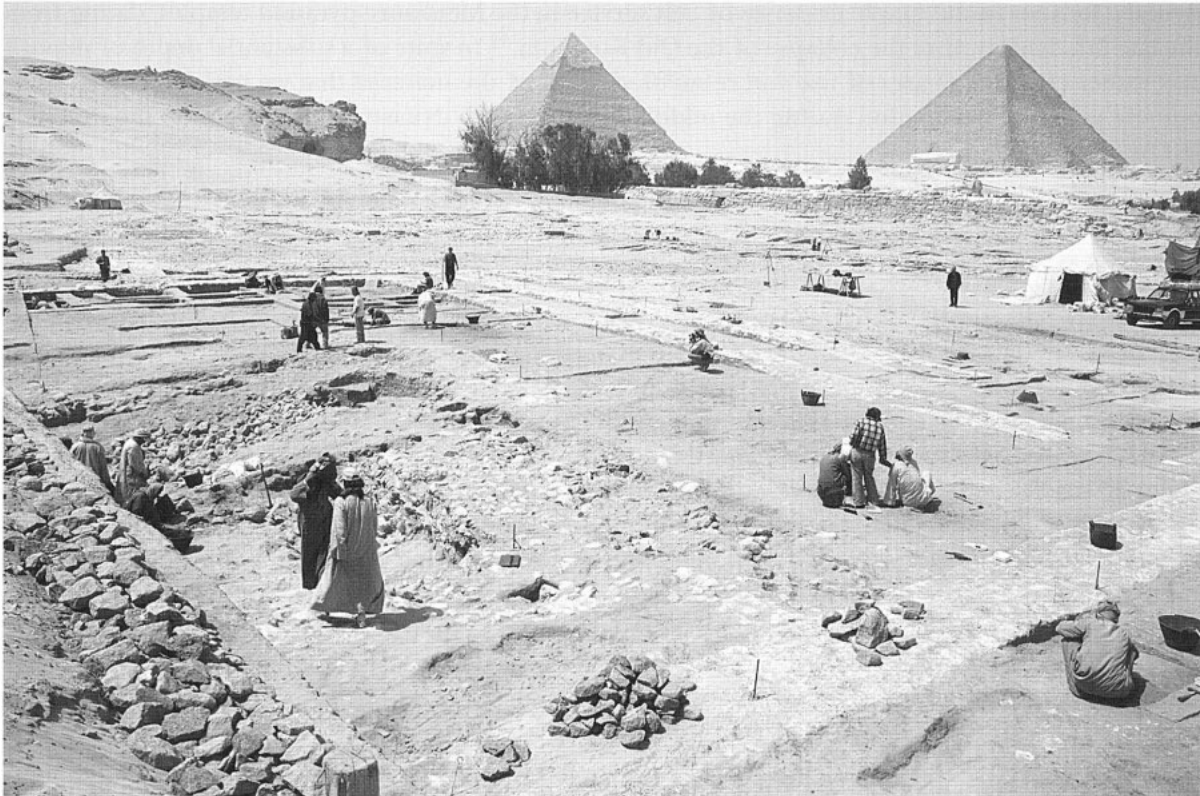
Fig. 3. General view of site, looking from the southeast across the royal administrative building to the Wall of the Crow in the northwest. The stone-filled depression in the foreground is the sunken court of silos early in its excavation.

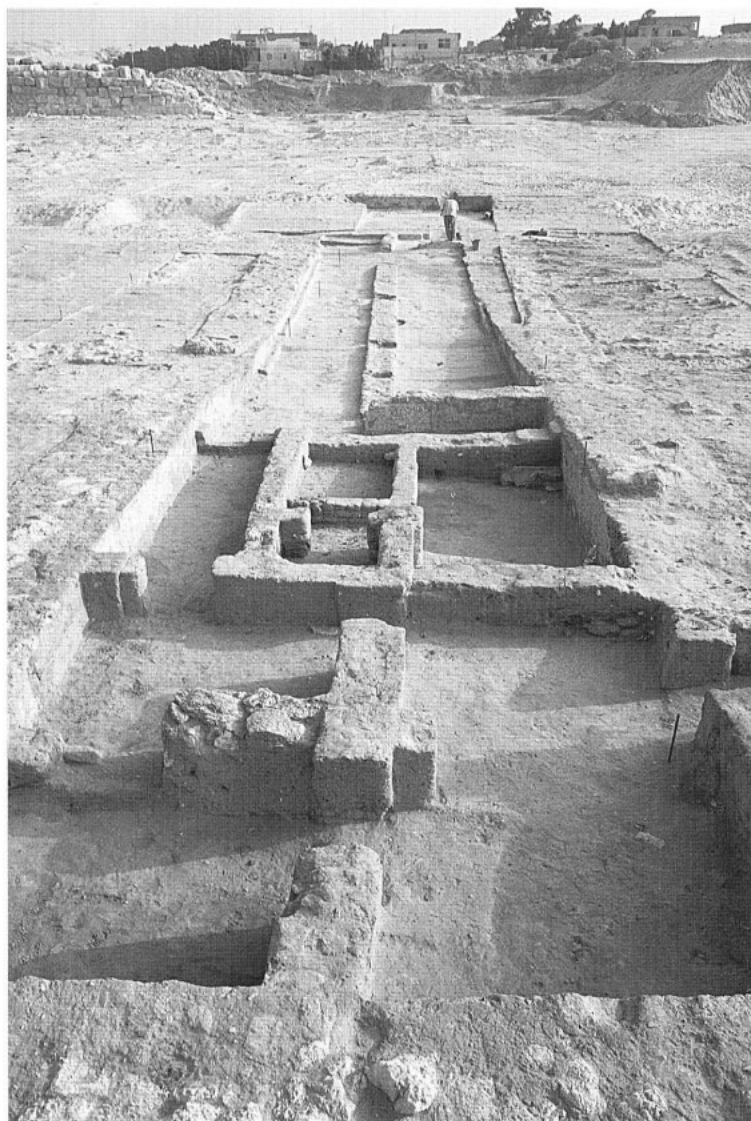
Fig. 6. View of Gallery III-4, looking north. The back chambers for cooking roasting and baking are in the foreground fronted by the house.

The internal arrangements that we have recovered within the galleries include elements also found in ancient Egyptian houses: a columned area that was open and possibly "public," a domicile that was private, and cooking, roasting or baking areas in the rear of the structure, a kind of "kitchen." But the question arises as to why the 4th dynasty planners would elongate the elements of a house into a corridor with a one to seven proportion of width to length, and repeat the pattern in a series. To help answer this question, Ashraf Abd al-Aziz excavated an *entire* gallery, III-4, during our 2001 and 2002 seasons (see figs. 5, 6).

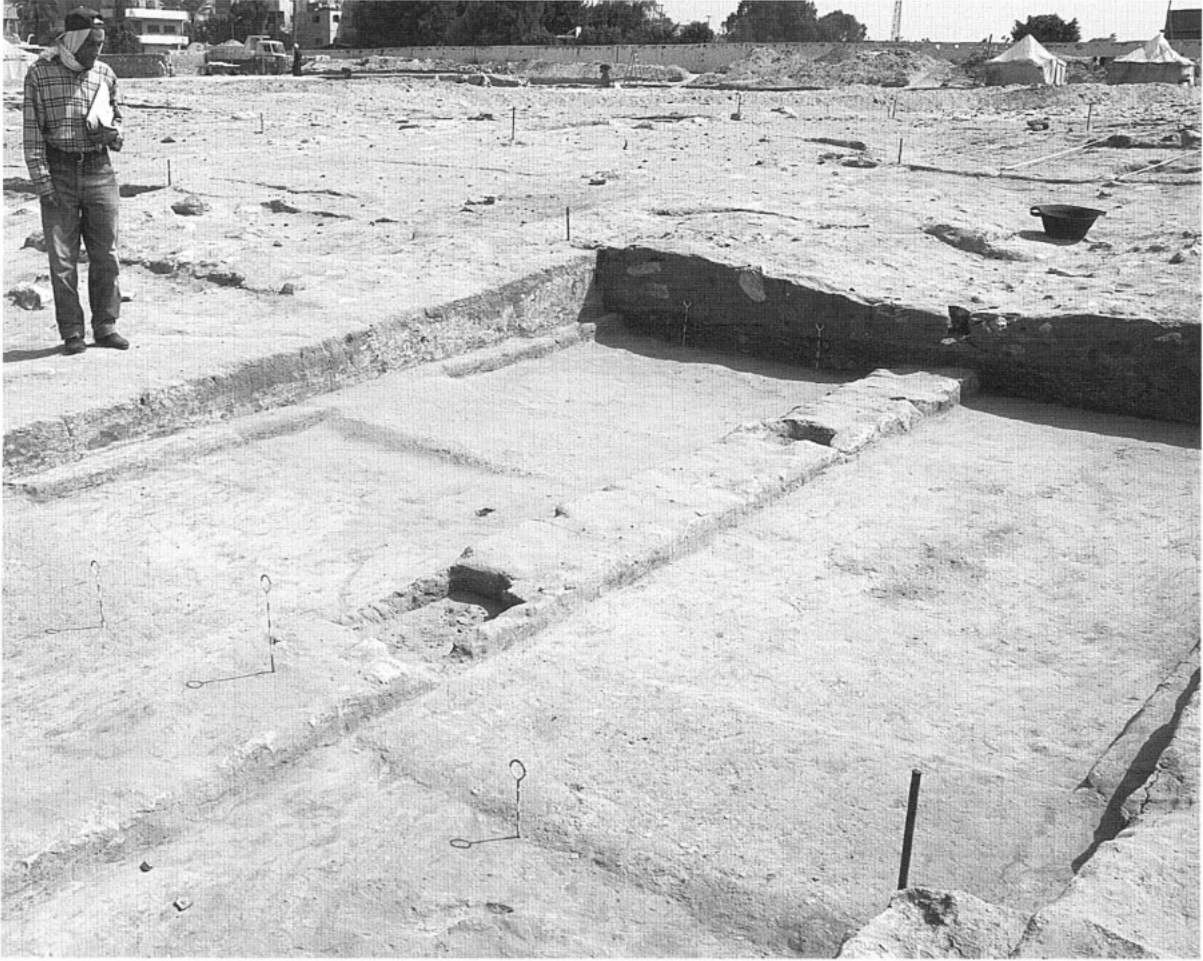
Fig. 7. Gallery III-4, two sleeping ramps, looking southeast. The stylobate with holes marking the positions of column bases runs down the center of the room. The curbs or small ledges are visible on both side walls.

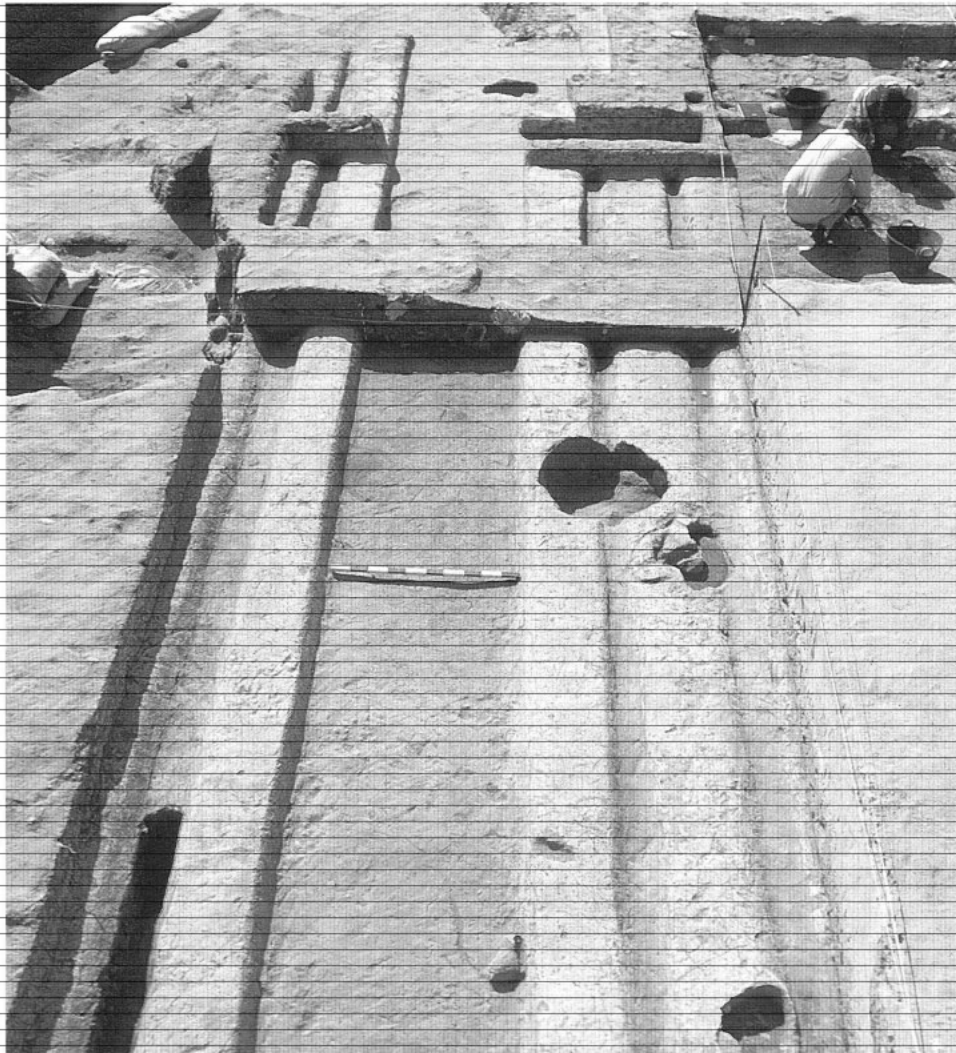
Fig. 9. Hypostyle hall, looking south. Troughs and benches with column bases run north-south through the chamber. To the upper right, excavators uncover another set of benches in 1995.

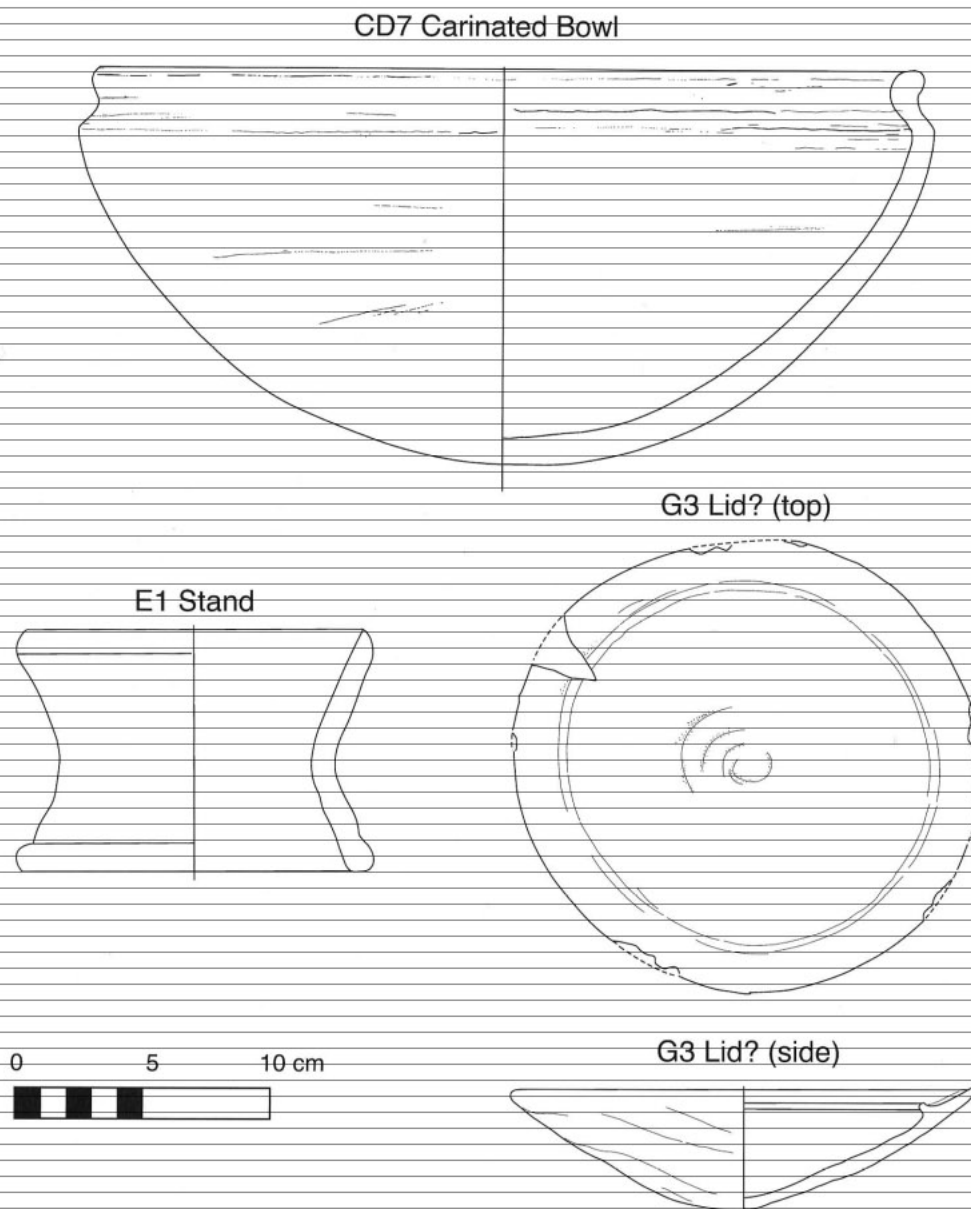
Fig. 10. Ceramic types found in the hypostyle hall: CD7, a white washed carinated bowl; G3, a shallow bowl with an internal flange that may have served as a lid; and E1, a jar stand.

This small hypostyle is perhaps the oldest one so far known in Egypt, except for the token hypostyle in stone at the west end of the entrance hall in the Djoser Step Pyramid complex.²⁰ Our hypostyle appears, however, to have served some practical rather than ceremonial function. Possibilities range from fish or grain drying, to a dining hall. In 1991 we found a cache of complete jar stands (Type E2) and shallow bowls, of a type (CD32 and CD33) that might have been lids, on or near one of these benches in square F20 (then designated Area A7b).²¹ Later we found more complete examples of these types on and near the benches in other squares. We have also found, embedded in the floor and troughs of the hall, a number of fragments of our type CD7, a white washed, carinated bowl that may be unique to Giza in the 4th dynasty (fig. 10). Anna Wodzinska, our project

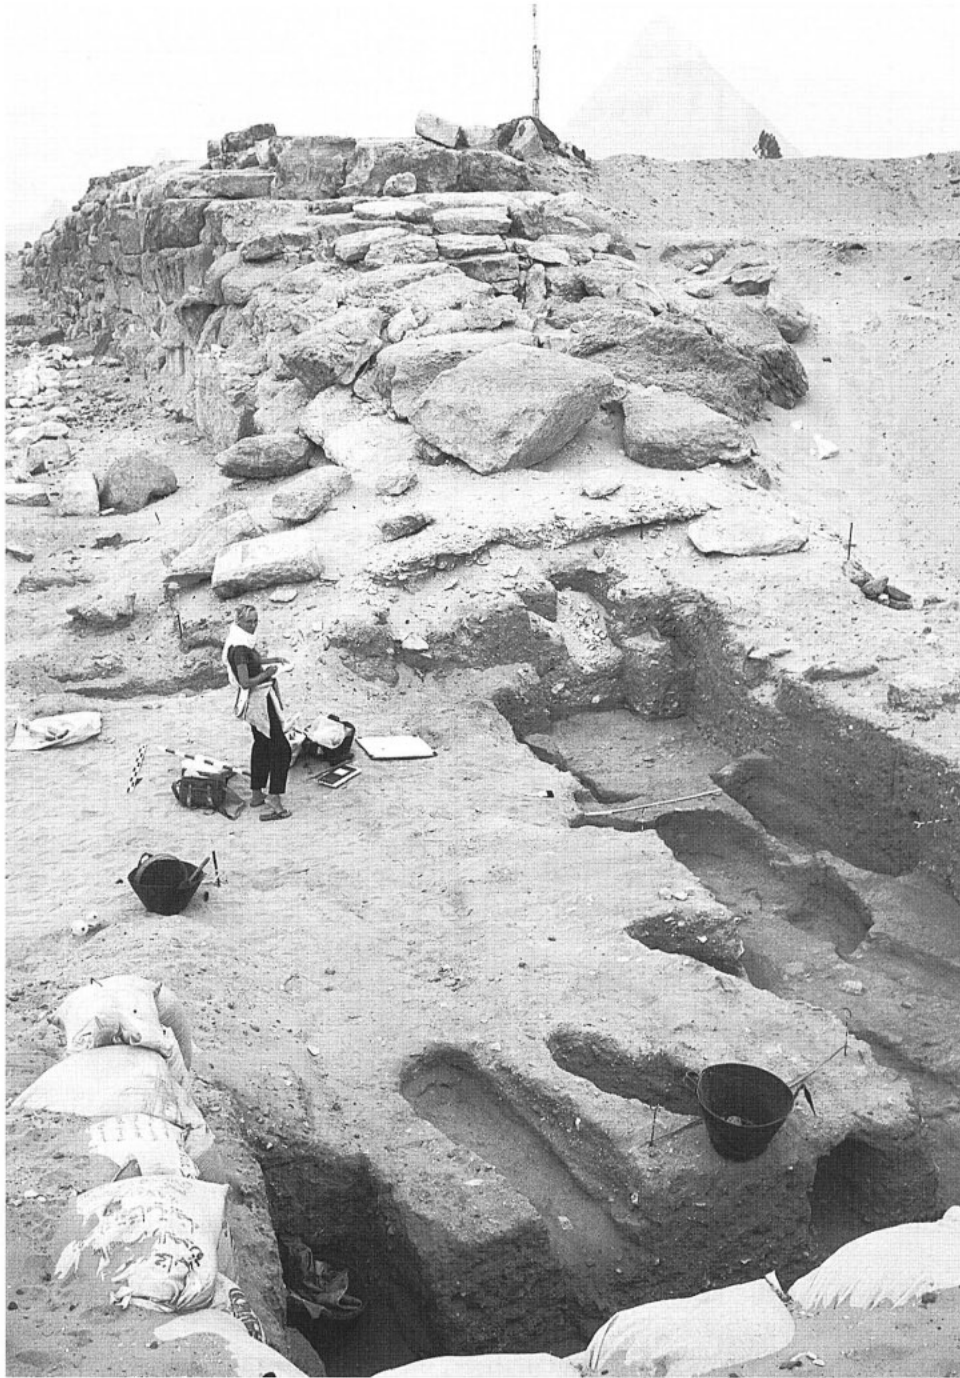
Fig. 11. View looking northwest of east end of the Wall of the Crow and Operation WCE in 2001. Lauren Bruning excavated the L-shaped trench, punctuated by Late Period burial pits, through the granite dust to the remains of a mud brick gallery. Two layers of large stones displaced from the east end of the wall delayed our search for the stratigraphic connection to the Wall of the Crow. In 2002 Bruning excavated these layers and extended the east-west trench to the true east end of the Wall of the Crow.

m wide to minimize the number of burials we would have to excavate and record. However, the Season 2001 team encountered eight more burials within this trench (fig. 11). Once again, under the granite dust, which is 85 cm to 1.30 m thick, the remains of mud brick gallery walls reinforced the idea that Gallery Set I continued as far north as the end of the Wall of the Crow.

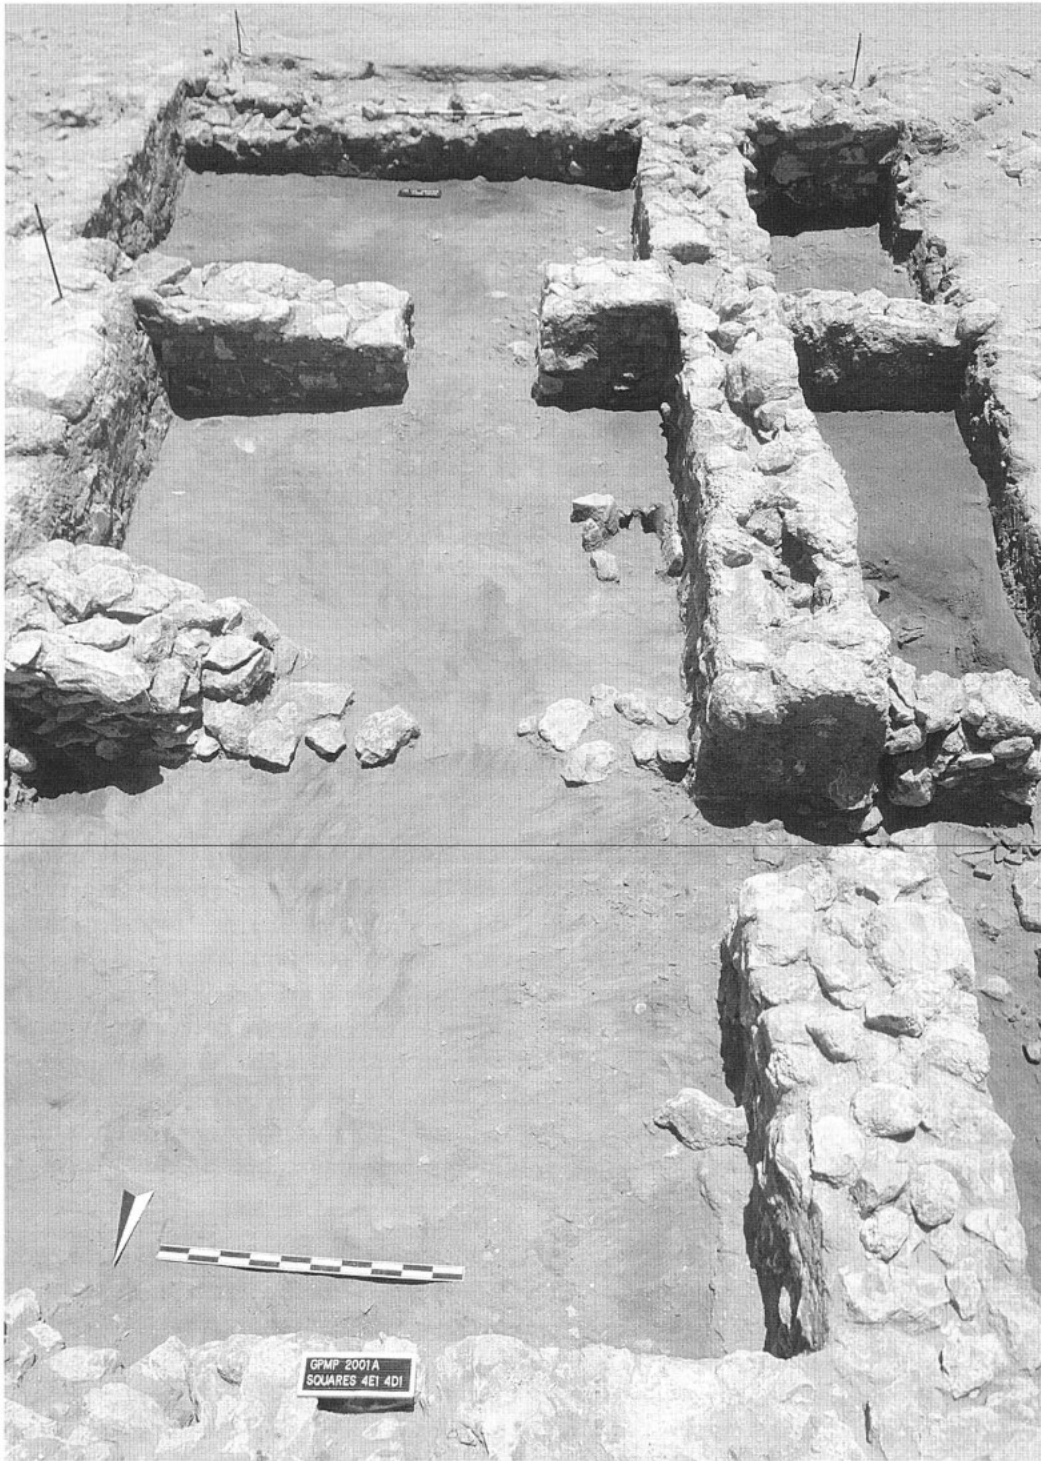
Fig. 14. View of Squares 4.D1 and 4.E1, looking south. Fieldstone was used as foundations for walls that were continued in mud brick. Ashy deposits fill the chambers above the floor level of the first phase of the building after the second phase floor level has been removed.

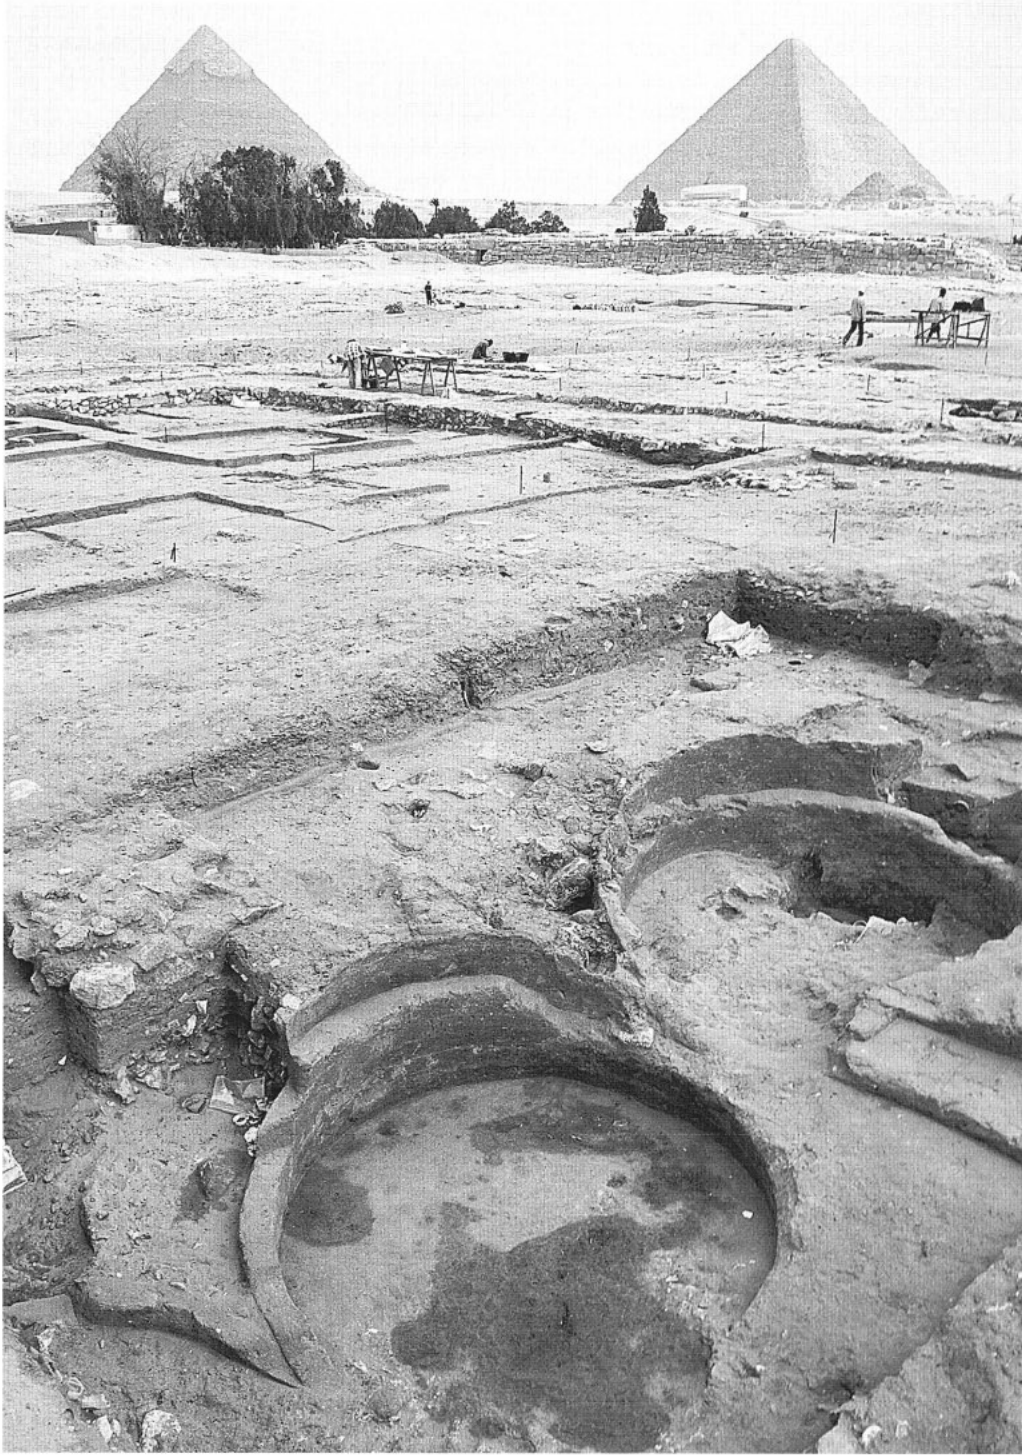
Fig. 17. Two of the silo foundations in the western side of the sunken court in the Royal Administrative Building (BB). The northwest corner of the trench remaining from the robbed (parapet?) wall around the silo court is seen in the center right side of the view. To the left are the chambers on the higher floor level in the northwest corner of the building.

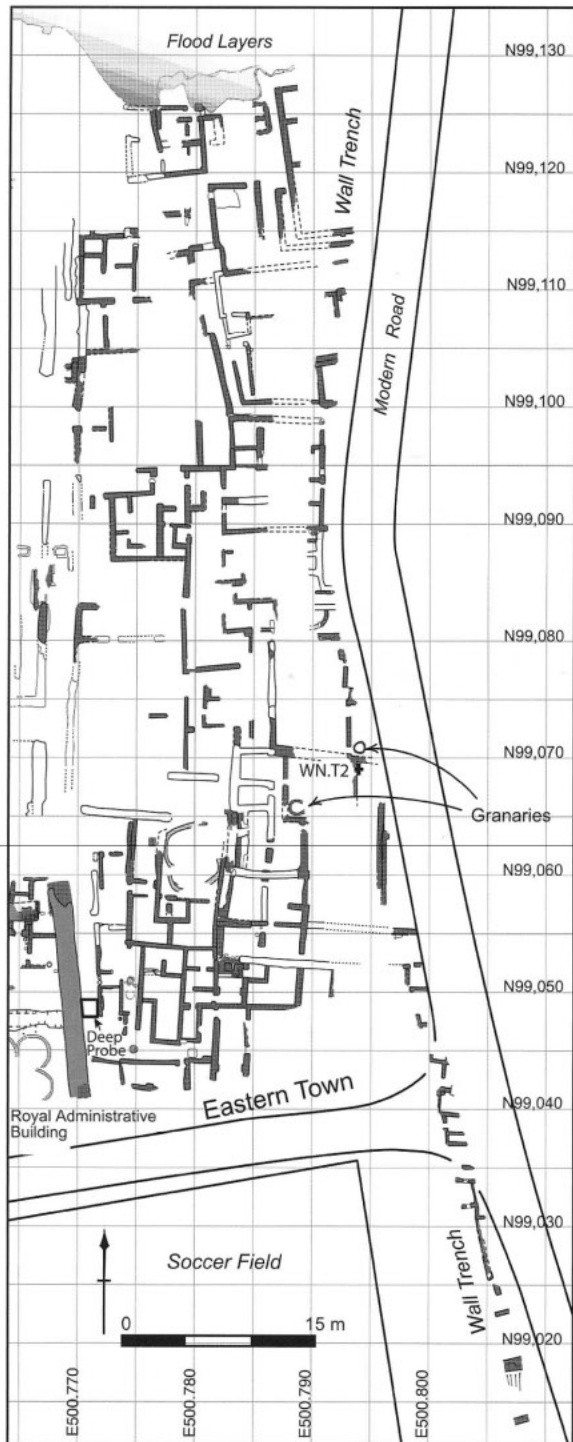
Fig. 18. Map of the Eastern Town, including the traces of walls mapped in the foundation trench for the new high security wall along the modern road. The road to the "Workers' Cemetery" and the soccer field of the Abu Hol Sports club limited our exposure of the settlement on the south.

The arrangement of structures we found was very different from the formal, large-scale planned architecture of the gallery system and the administrative building (figs. 18, 19). The layout is more or less regular and approximate to the cardinal directions. The orientation of the southern part is

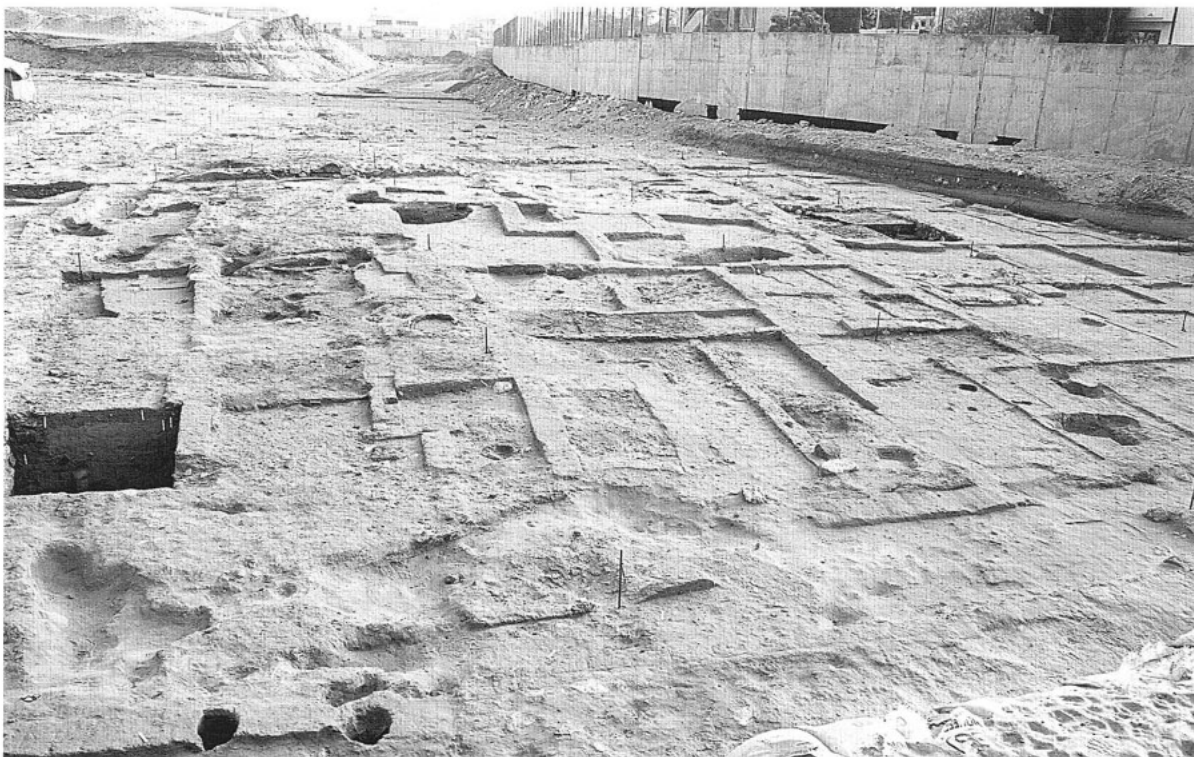
Fig. 19. General view of the Eastern Town, looking north. The new high security wall can be seen on the right side of the photo. The small, closely packed rooms of this area are very different from the rest of the site with its massive walls, large open areas, and large chambers. The deep probe along the eastern wall of the Royal Administrative Building can be seen on the left side of the view.

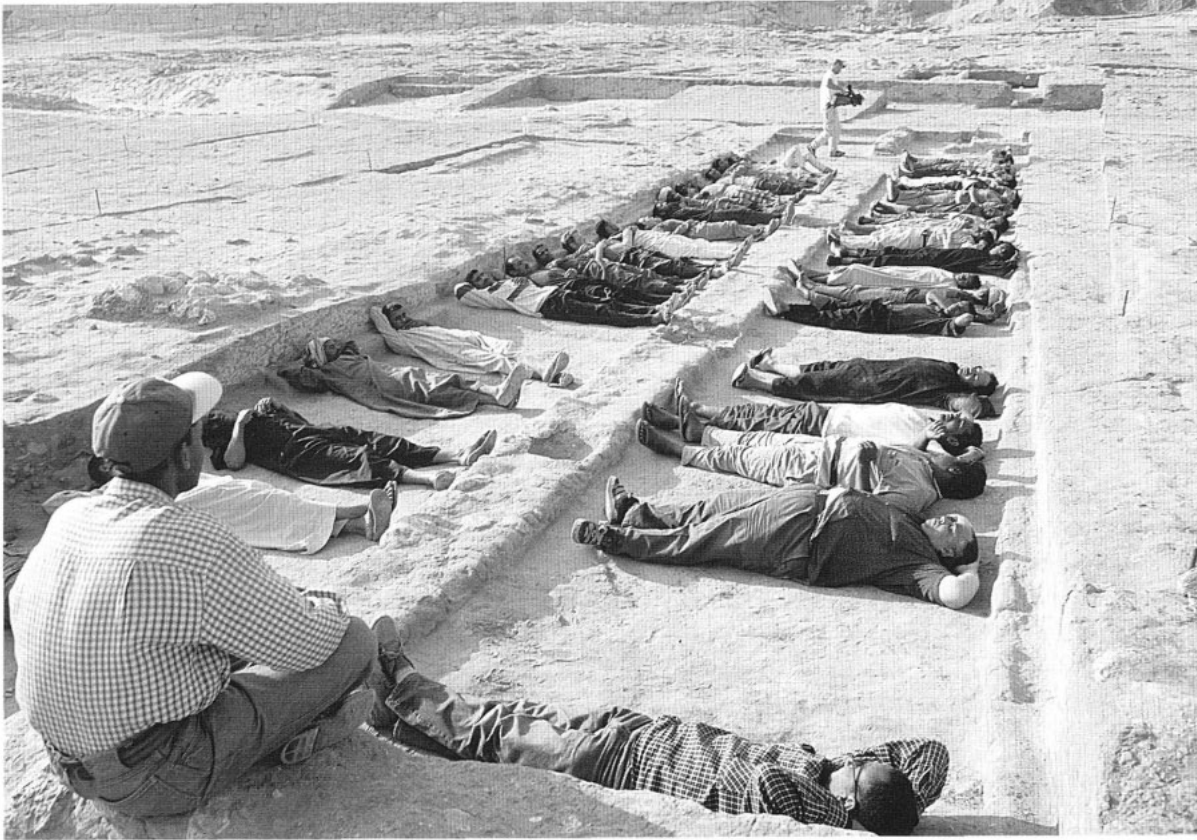
Fig. 20. Ashraf Abd al-Aziz counts “sleeping” team members and workmen who demonstrate how Gallery III-4 might have been used as a barracks. He is seated on the mud brick wall separating the back house from the front part of gallery.
