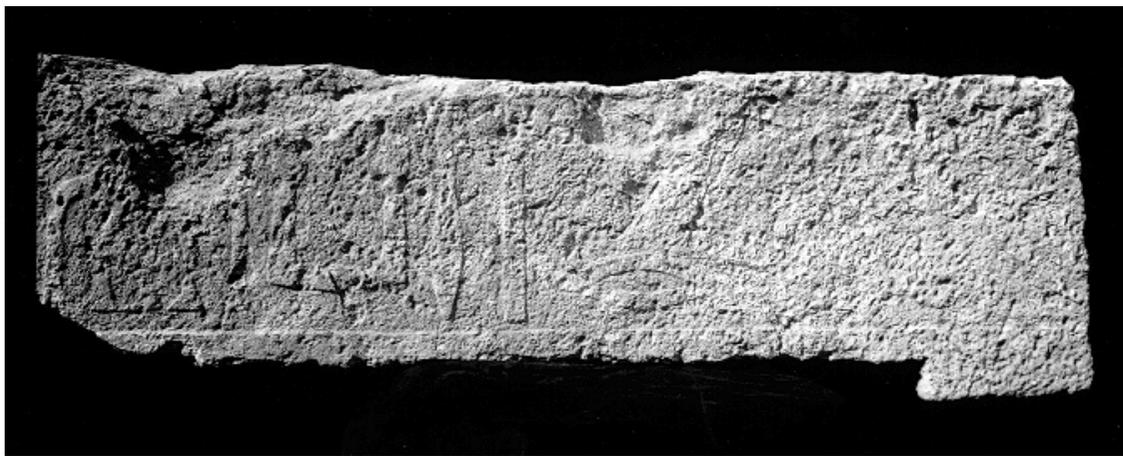
30a. 2088: southern third of the architrave from the portico, bearing the name of Kakhent. (The left end extends slightly beyond the photograph.) The protrusion at the right end rested on half of the southern pillar, and was joined to the middle section by a concealed tenon (see pl. 25c) (a 8062)

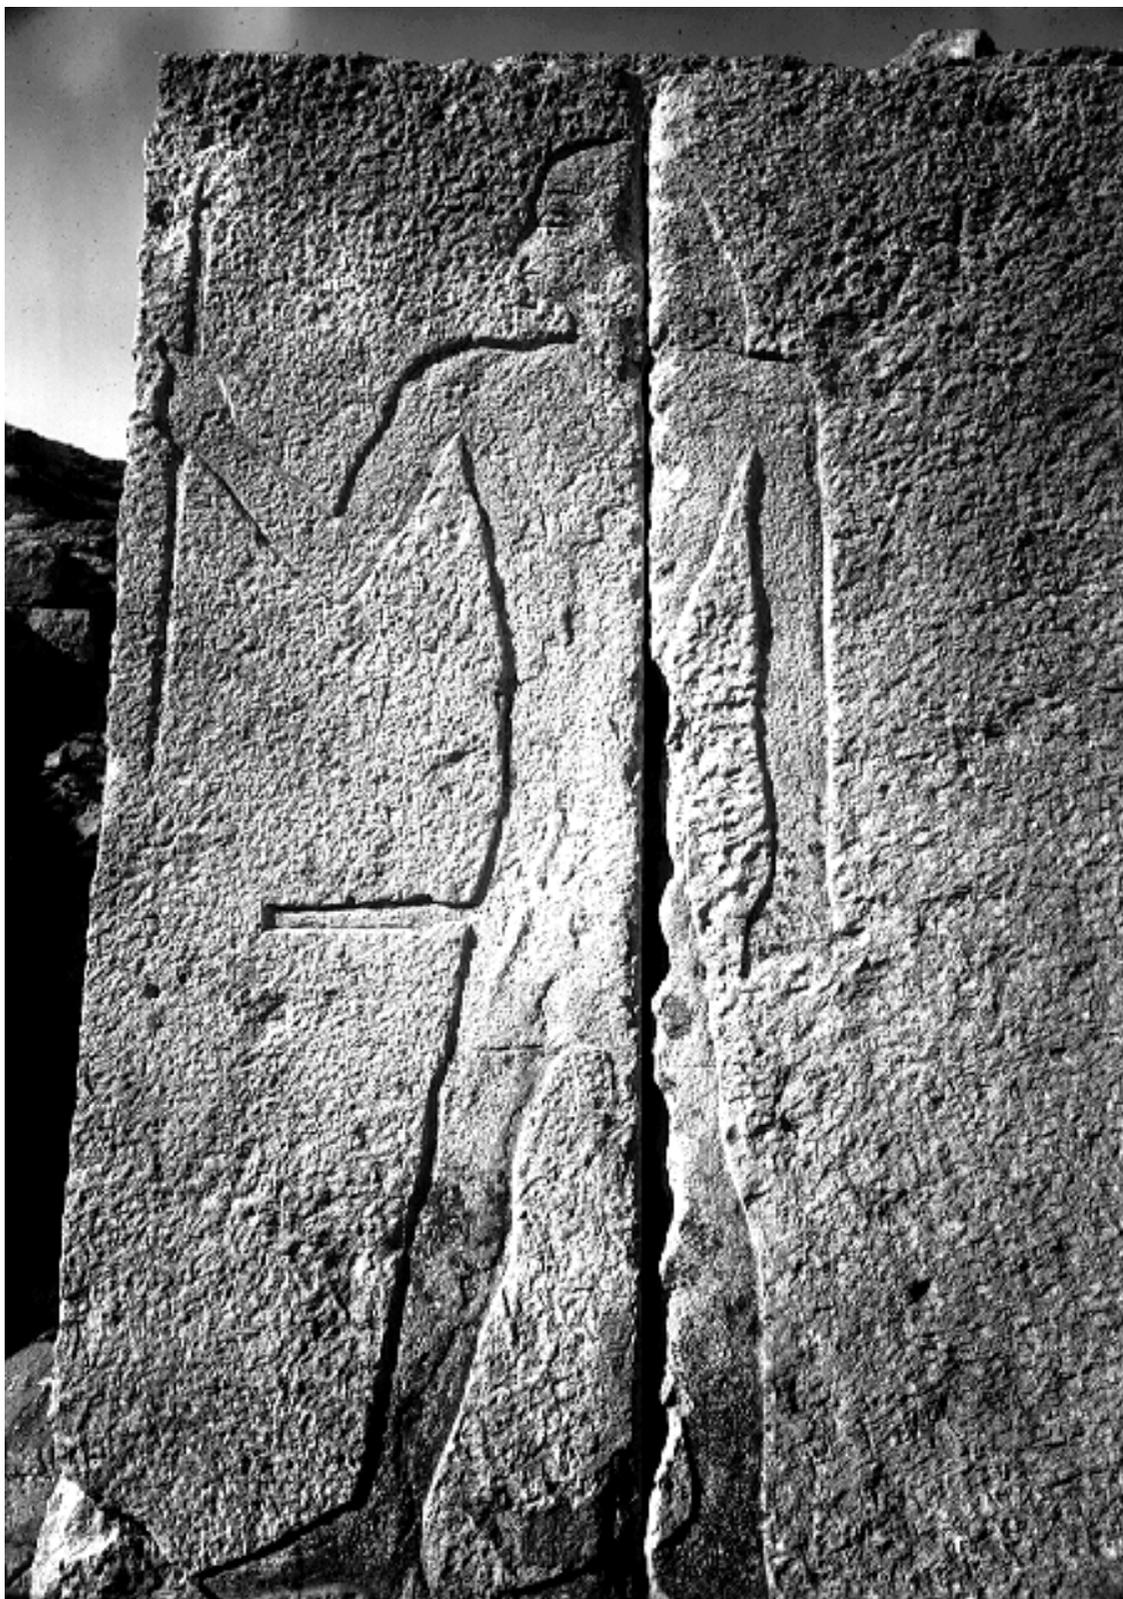
30b. 2088: sunk relief figure on ashlar facing the back of portico, north of the doorway. Since the figure is oriented facing into the chapel, it probably represents Pehen-Ptah, son of Kakhent, rather than the tomb owner himself (a 8063)

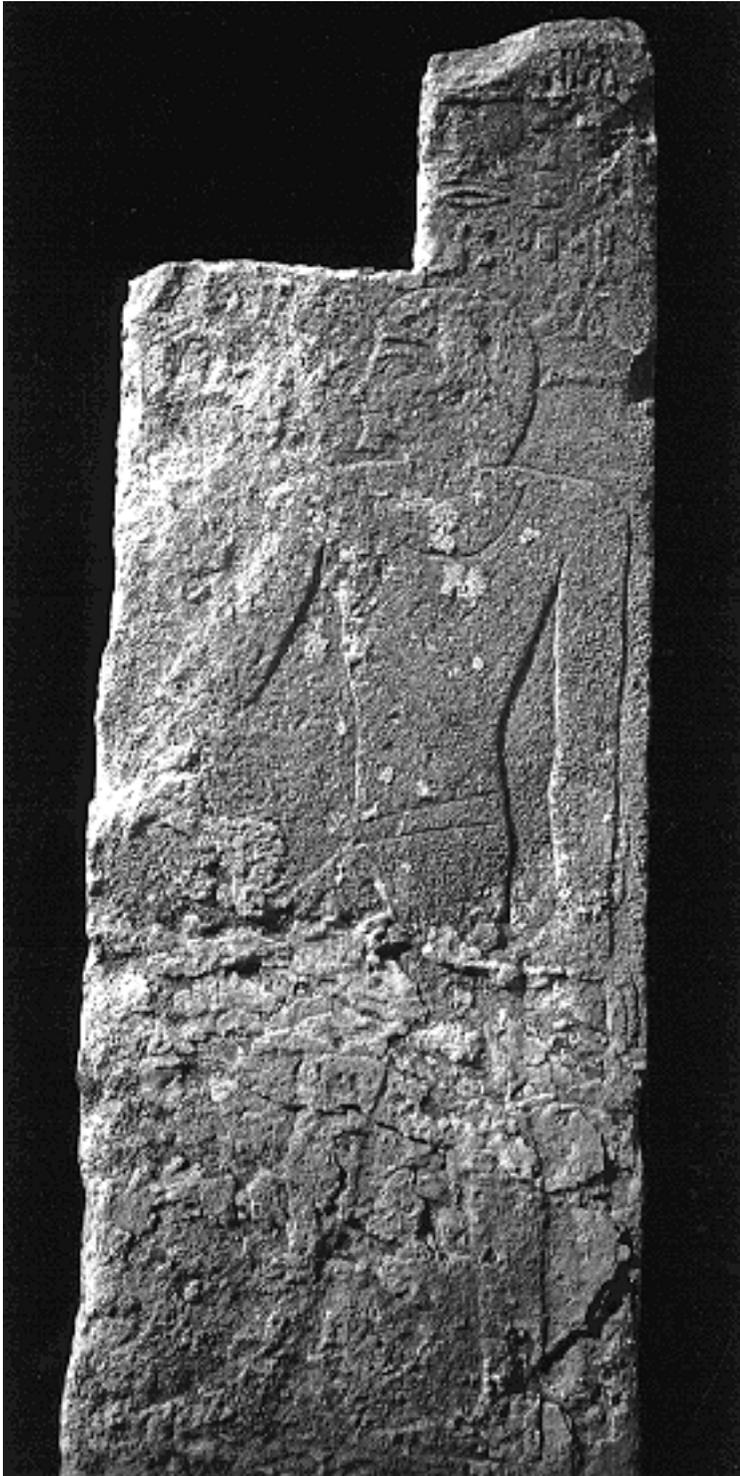
31a. 2088: displaced northern doorjamb of the entrance to courtyard. The notch in the upper left held a drum lintel. Probably, because his father Ka-khent was the principal owner of the tomb, Pehen-Ptah is anomalously shown entering the door rather than leaving, his arm raised in greeting (a 8059)

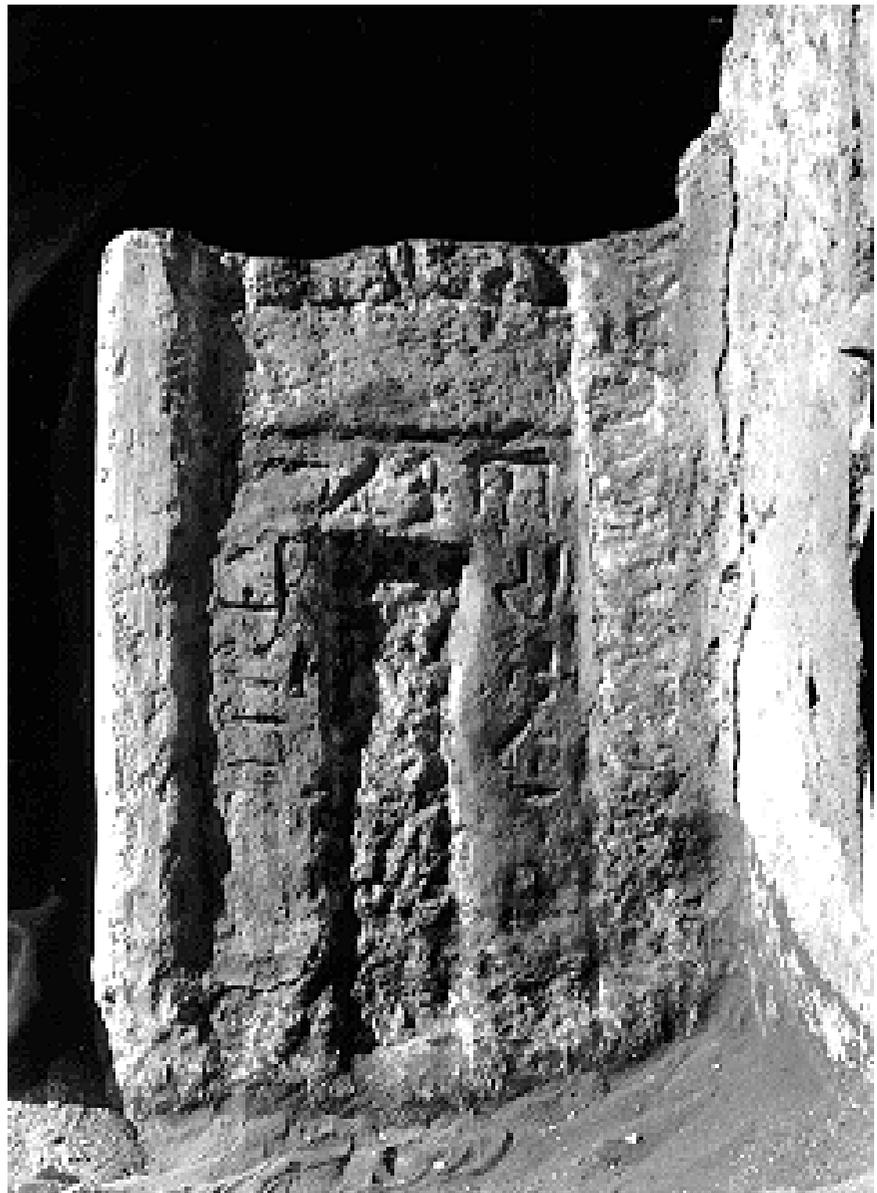
31c. 2088: small secondary false door of the woman Ankhimaes, a mortuary priest of Kakhent, built to the right of the entrance to the inner chapel. The same woman is probably represented in one of the tomb's serdab models (see fig. 32) (c 14257)

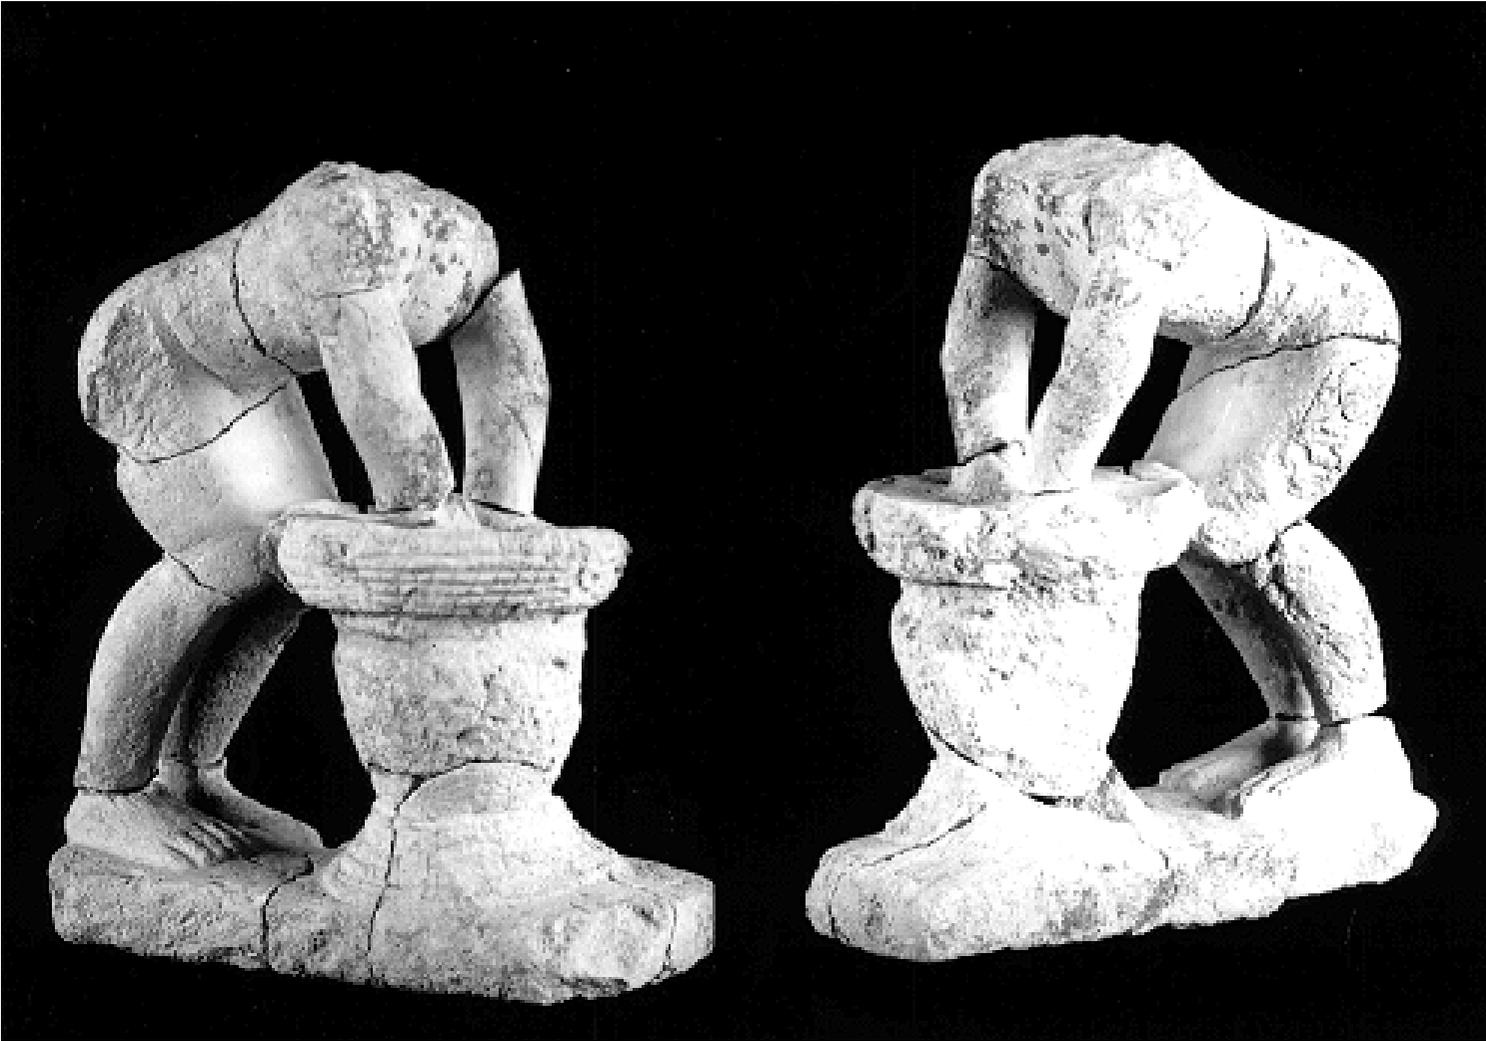
33a. 2088: two views of a serdab model of a man sieving grain, 39-3-4 (b 9083, 9085)

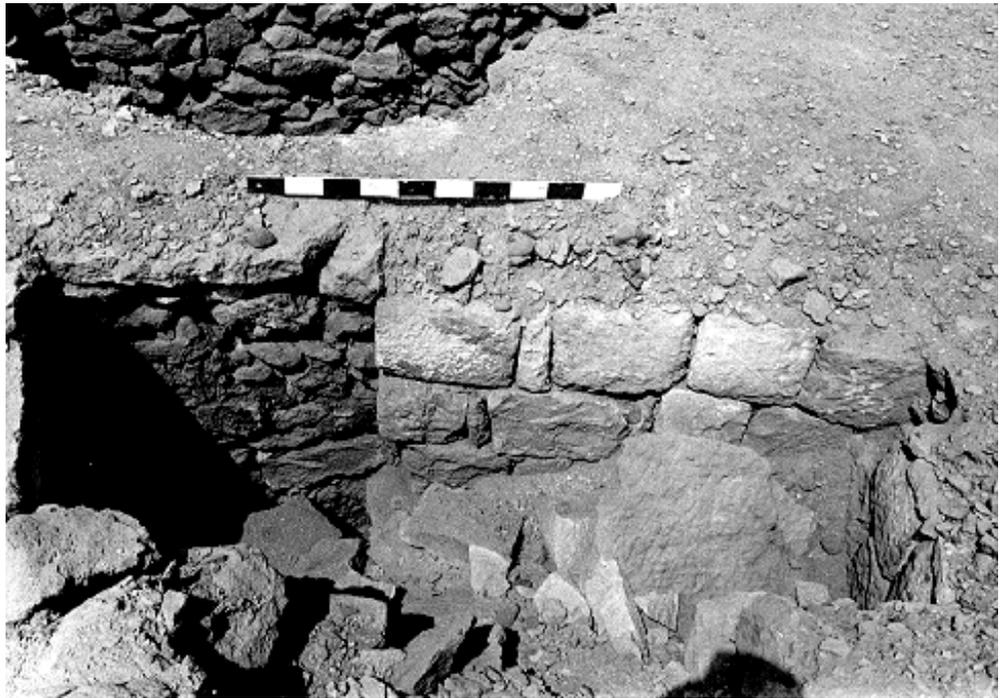
34a. 2088 e: shaft and burial chamber. The shaft was lined with rubble, but the walls of the burial chamber were better built, of masonry, in order to support the roof, which was of slabs when the shaft was excavated, but is now missing (rg 14-30, 1989)

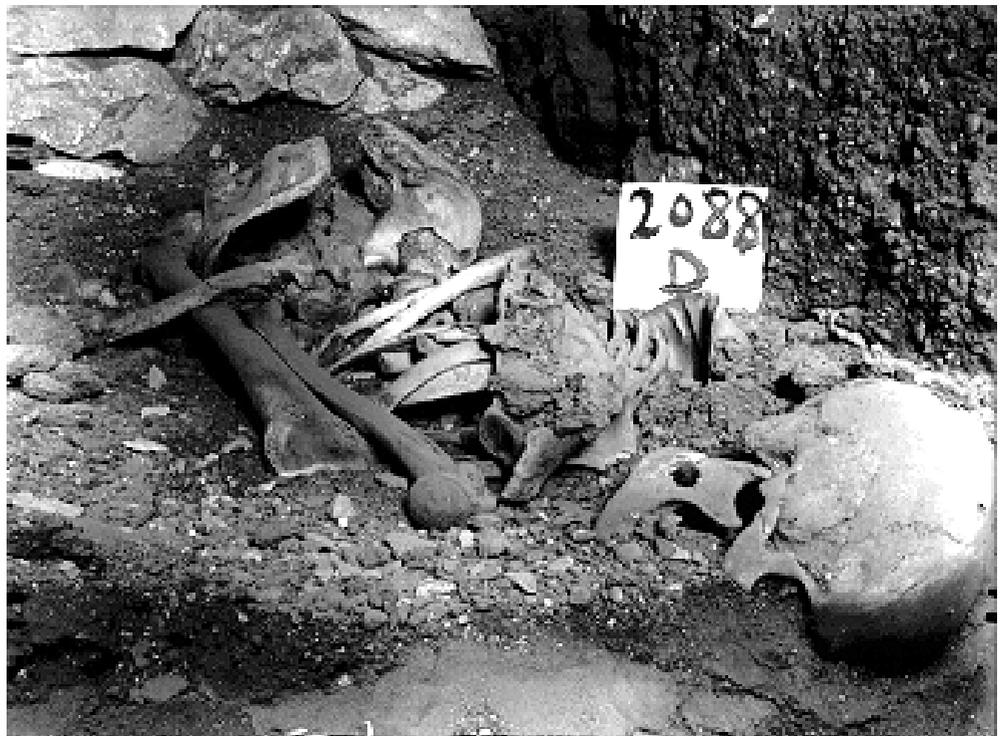
34c. 2088 f: burial, possibly of an older adult, with moderate to severe osteoarthritis. Although characterized as "contracted" in Reisner's summaries, this skeleton is perhaps better described as "tightly contracted" (see pl. 34b) (c 14162)

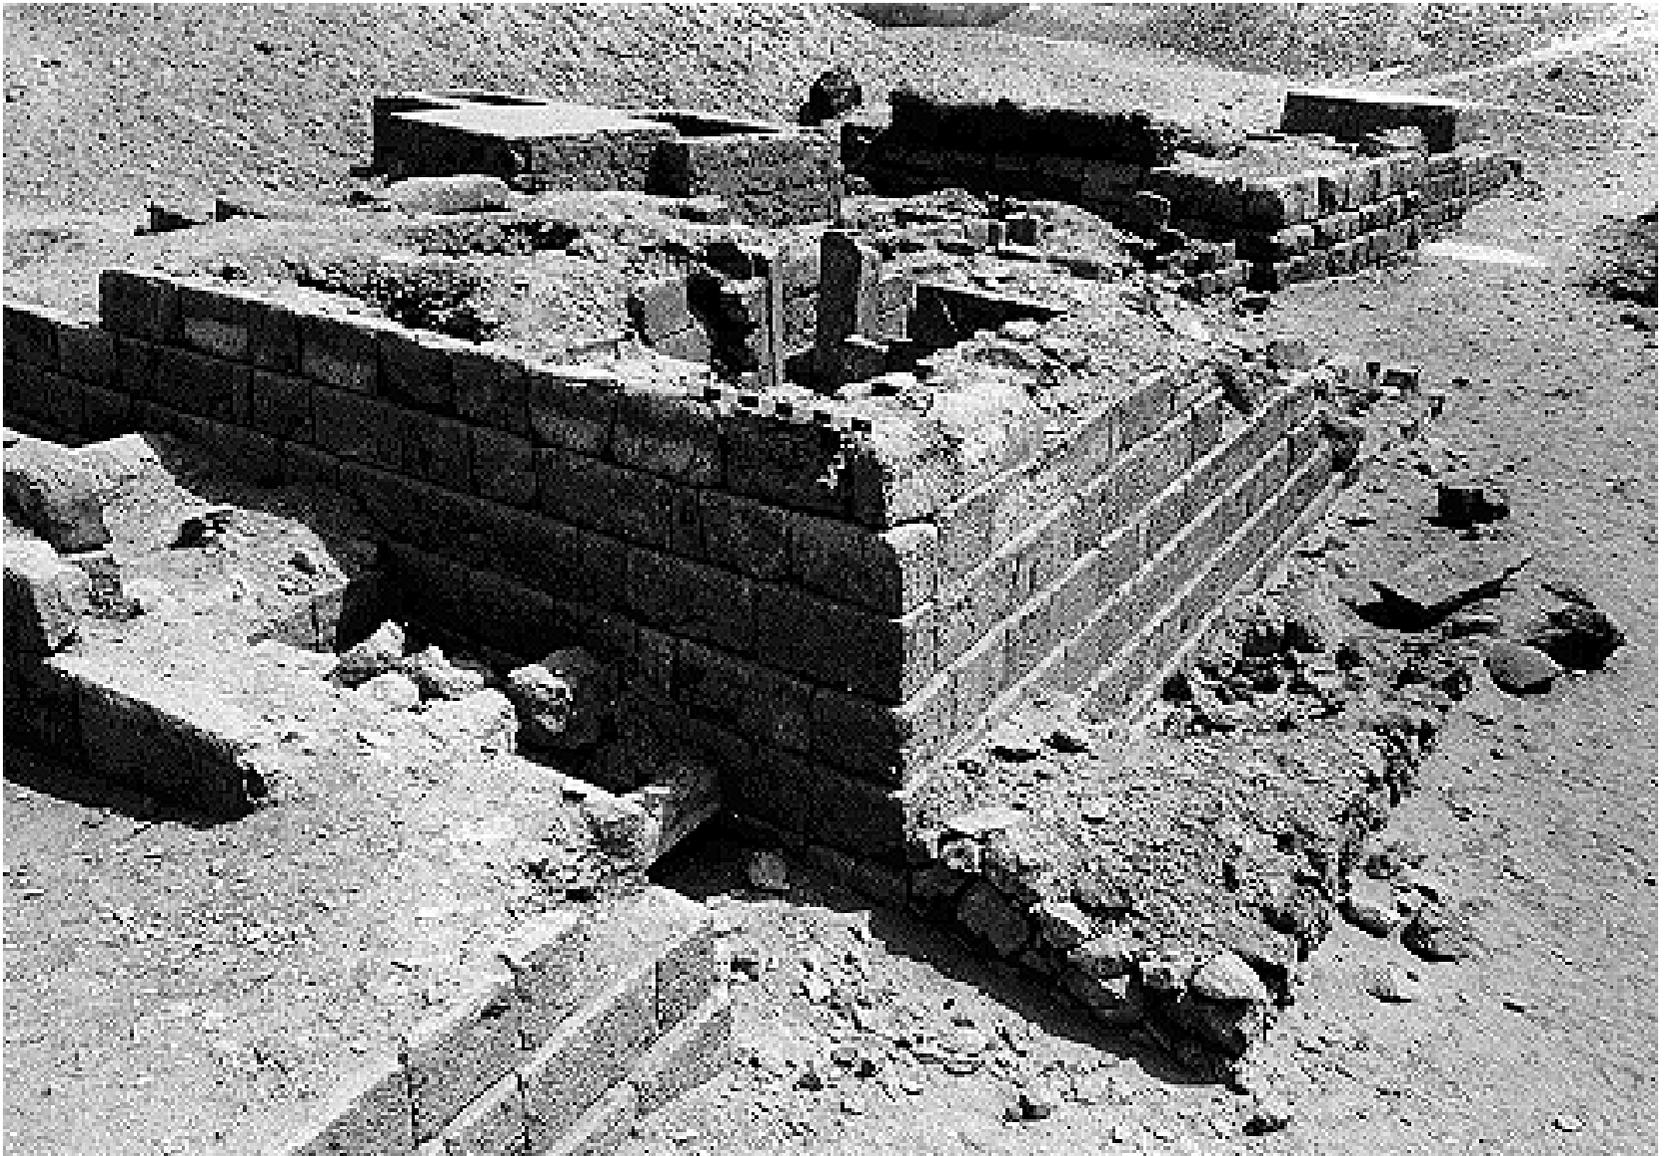
35c. 2088: view from the southwest, illustrating its stepped casing and the rubble construction along its southern face. At the lower left is 2089, also with stepped casing. The southernmost of three intrusive shafts and burial chambers between the mastabas is visible (rg 14-31, 1989)

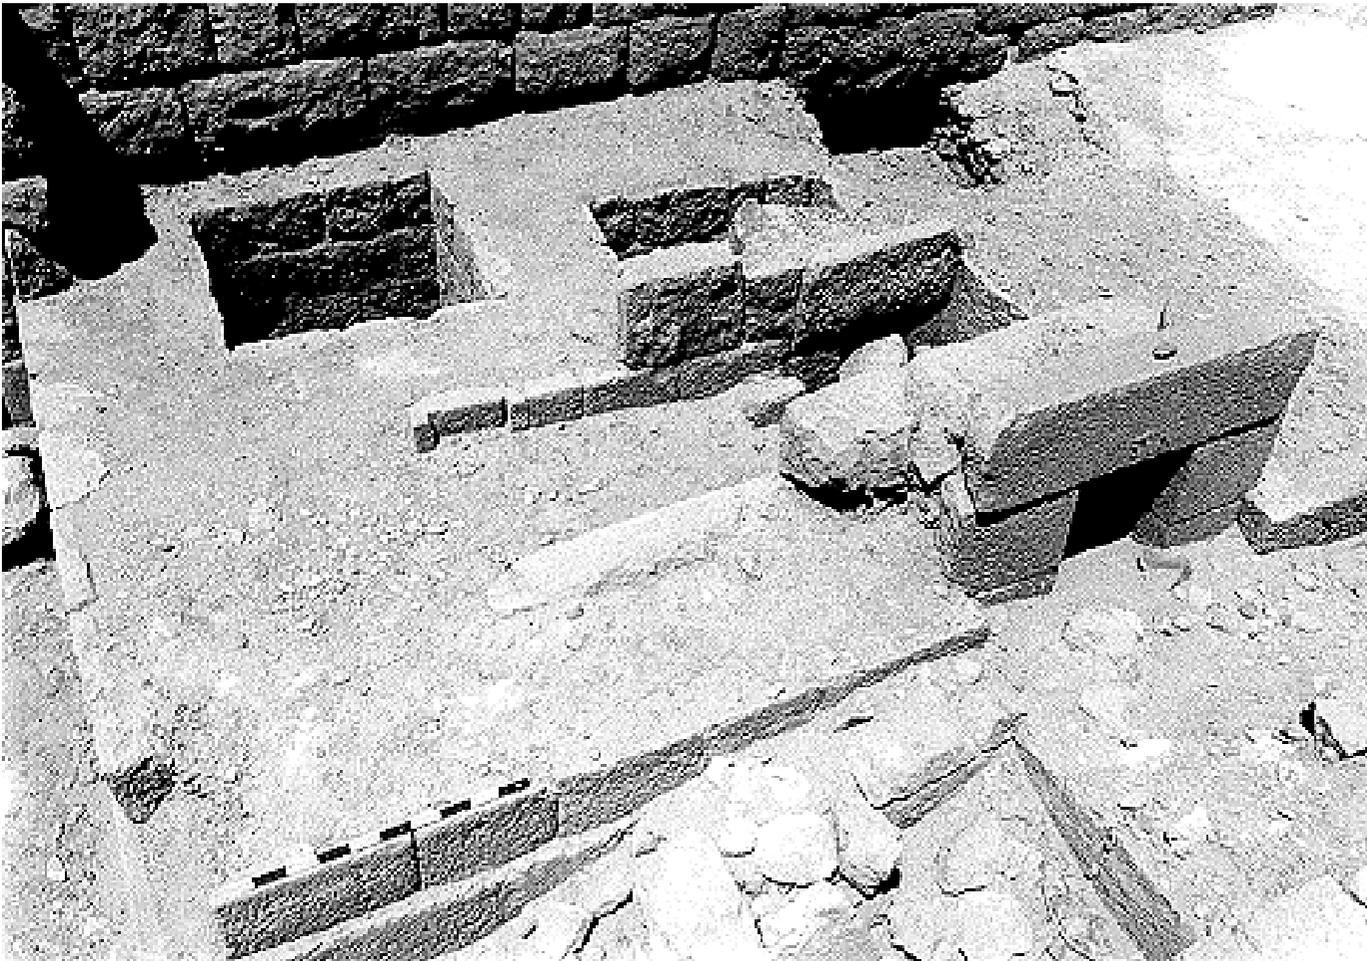
36a. 2089: entrance and L-shaped chapel with two false doors. Behind, shafts a and b flank a small serdab chapel. The entire mastaba, with the exception of the entrance and chapel, was reduced to a uniform level during Phase ii, so that the wall in the background could be built over it to support the corridor roof of 2091 (rg 10-27, 1989)

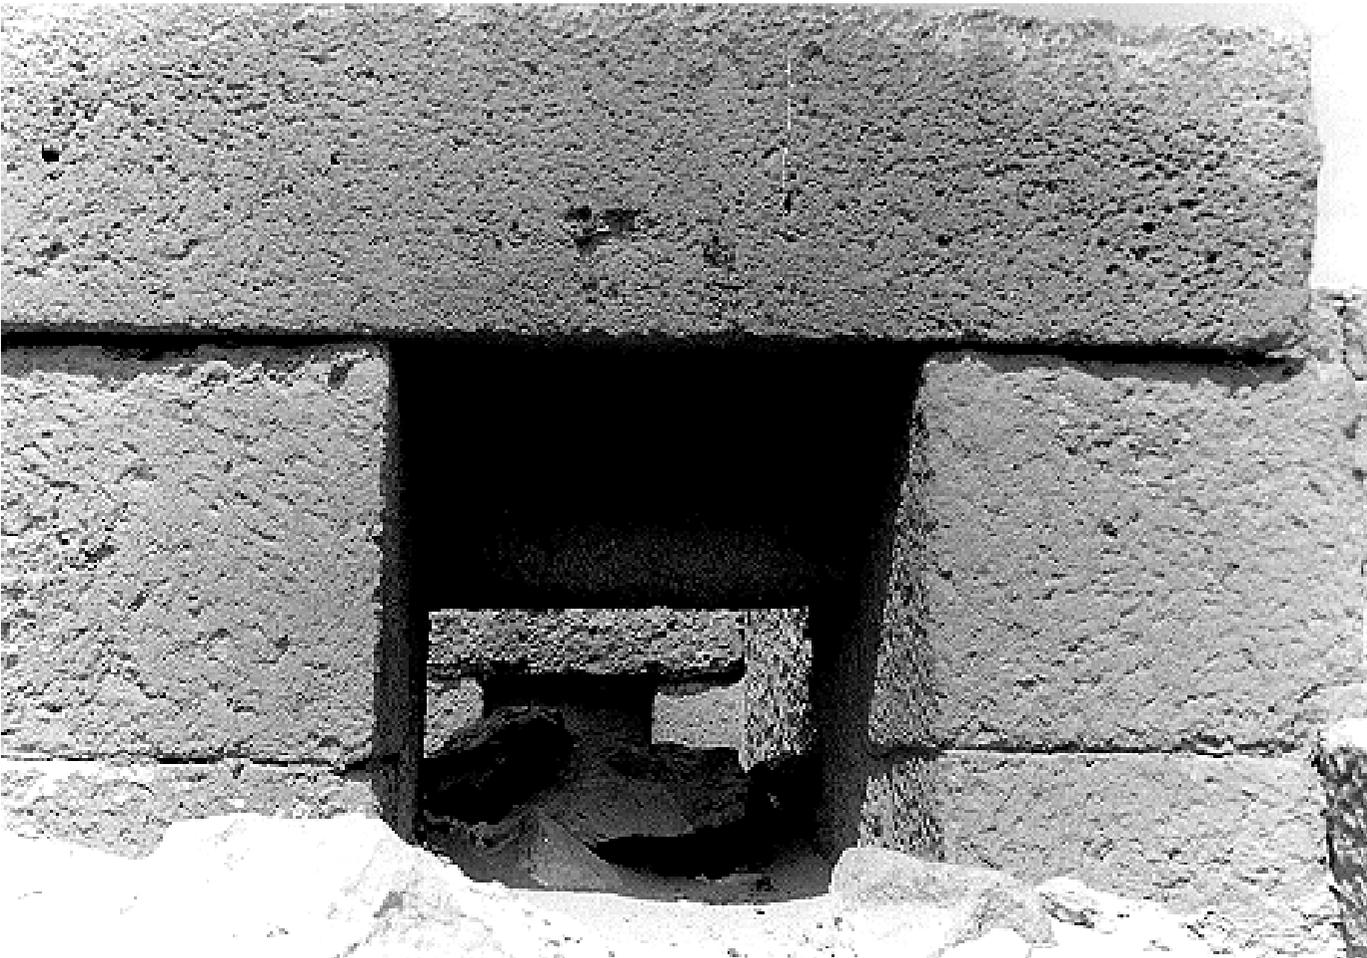
36b. 2089: view through the largely buried entrance doorway. Beneath the drum lintel, the lintel, jambs and part of the tablet of the northern false door are visible. A small opening at the top of the tablet is the serdab slot. The entrance and chapel of this tomb were buried by four intrusive shafts and burial chambers (amr, 1990)

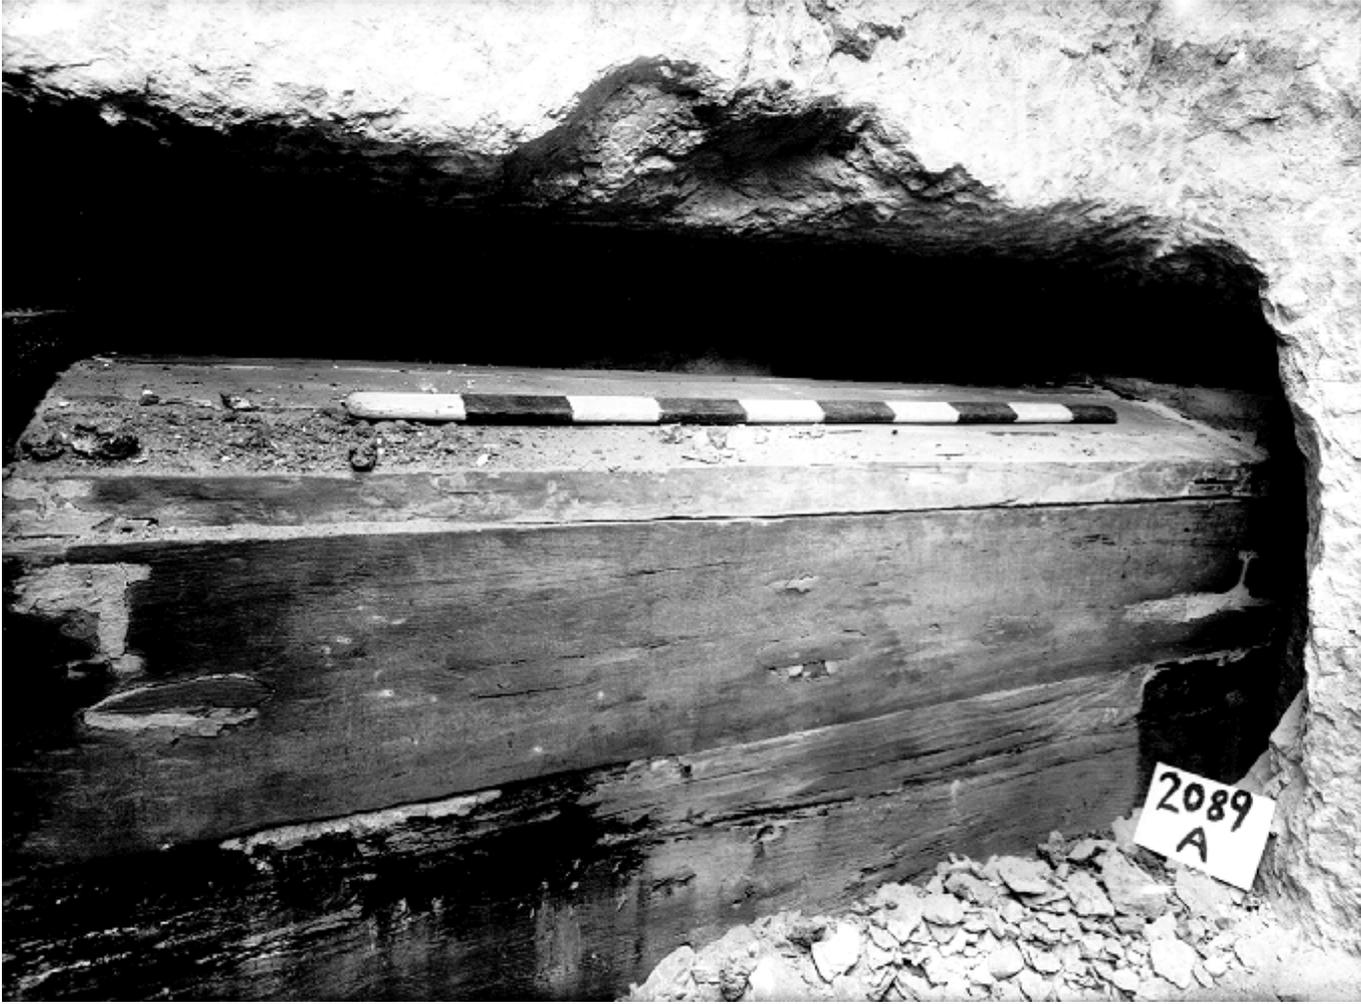
37a. 2089 a: burial chamber, containing a wooden coffin with a *kerst* lid (a 7985)

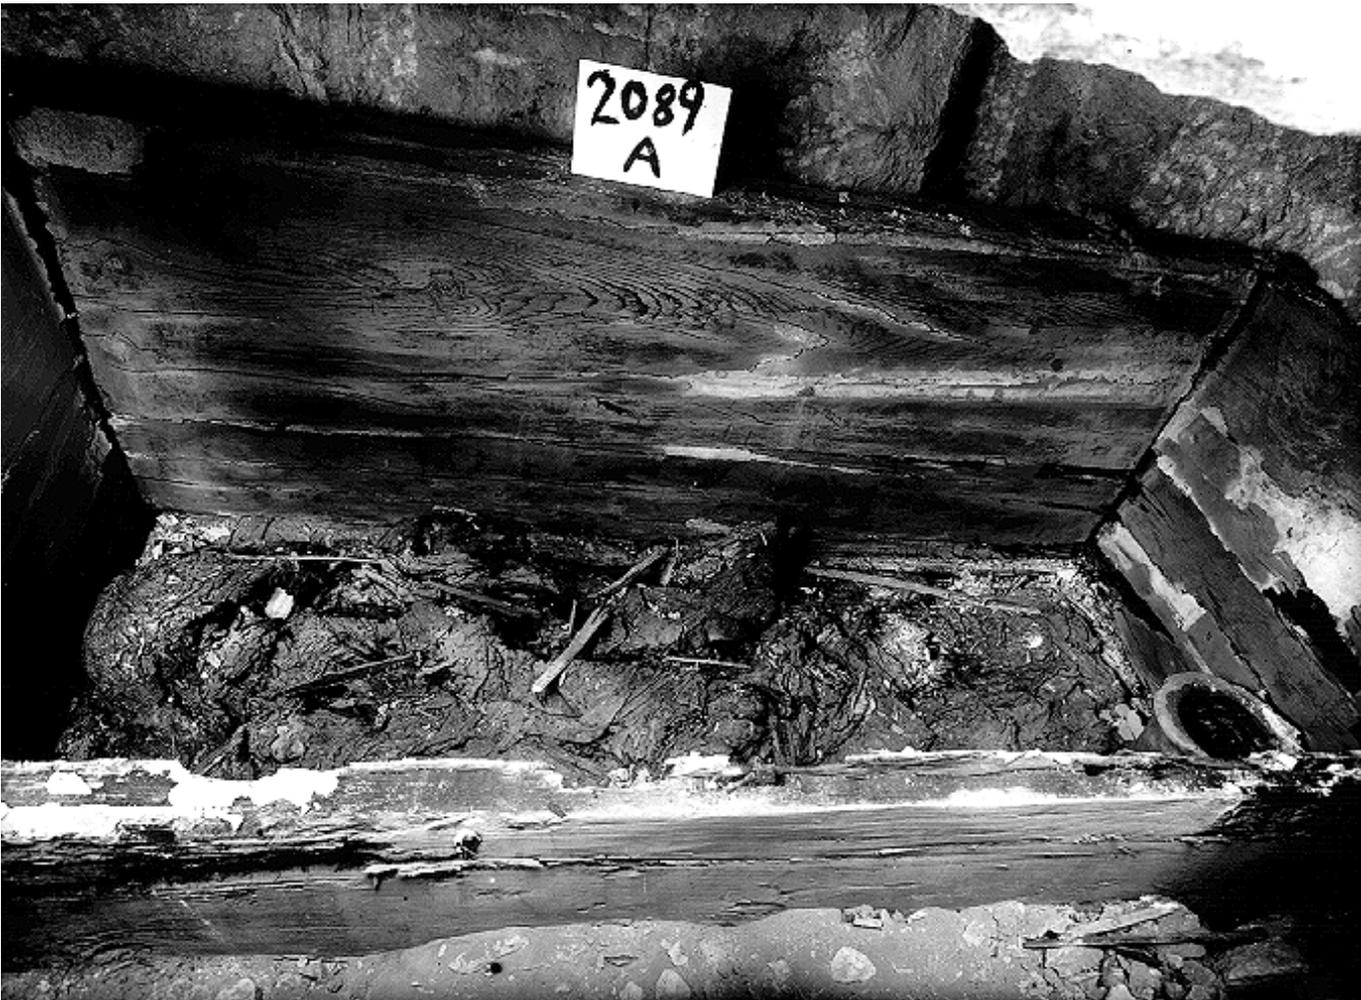
37b. 2088 a: burial after the removal of the lid and side board of the coffin. The body is half contracted and thickly wrapped in linen. In the southwest corner of the coffin is a cylinder jar with a hieratic inscription in black ink, containing resinous remains (a 8011)

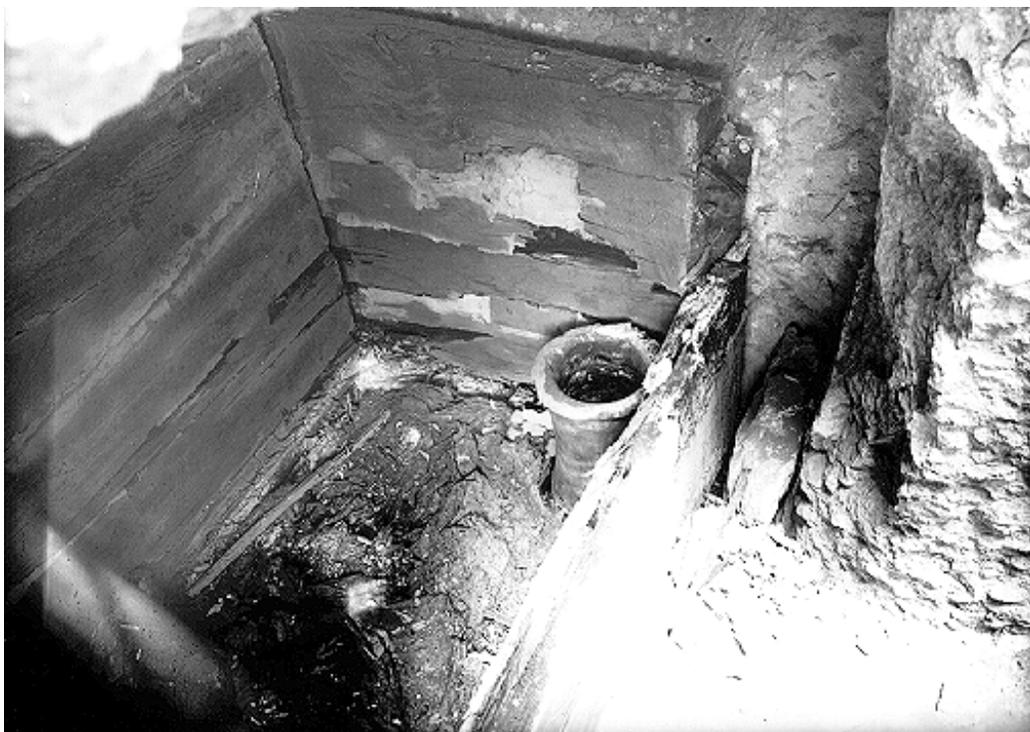
38a. 2088 A: detail of coffin and the cylinder jar inside it (b 8959)

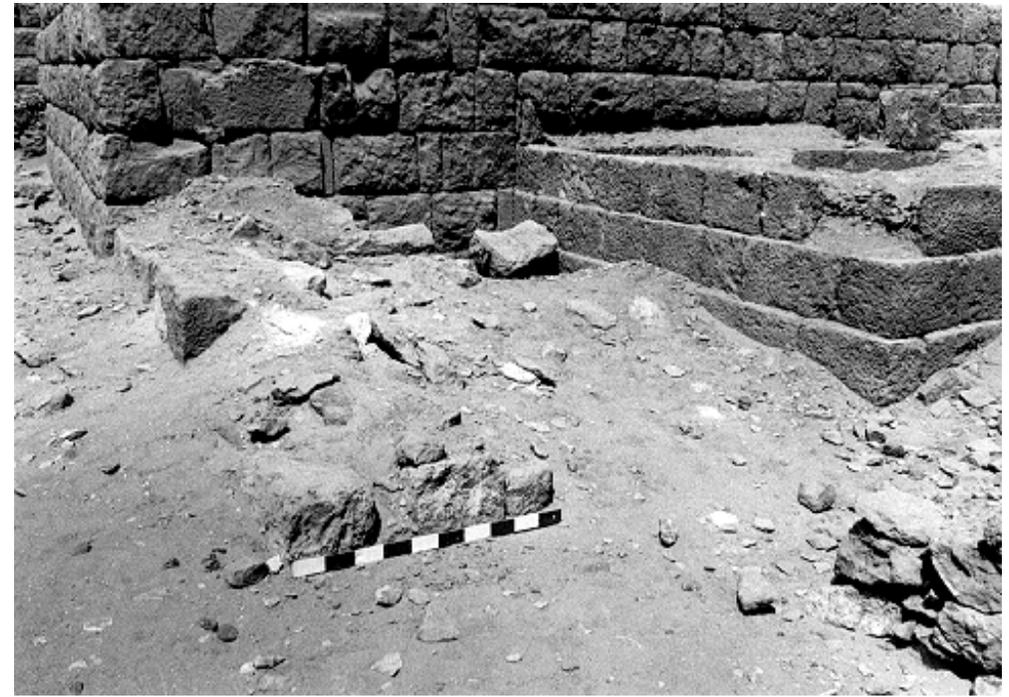
39b. 2089a: eroded remains of a mastaba built in the angle between 2091 and 2089. Excavations records indicate that there was a small recessed chapel with a central false door to the right of the photo scale (rg 10-21, 1989)

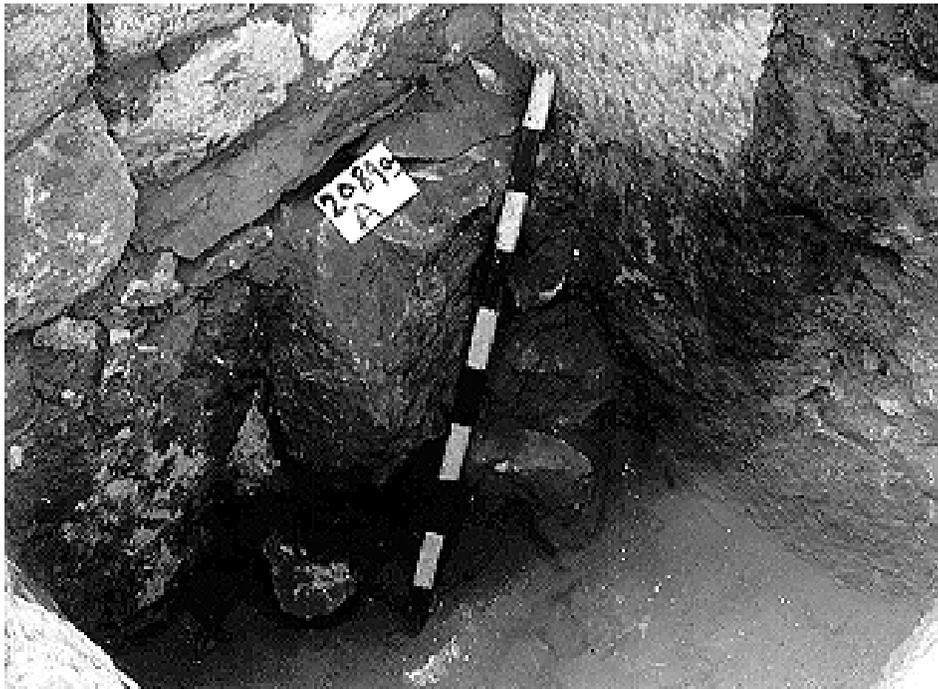
39c. 2089a a: blocking of Reisner's type v e(2), "a horizontal slab on which rests a leaning slab, completed with rubble bound with mud" (c 14288)

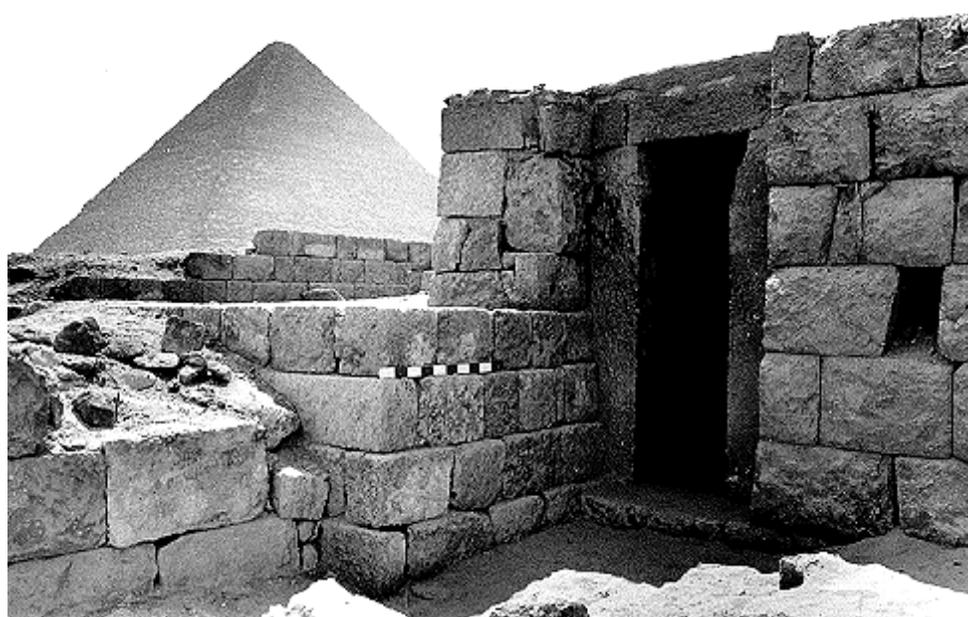
40b. 2091: northern entrance, with the stepped corner of 2089 left of the doorway showing the level to which it was reduced when the east wall supporting the 2091 corridor was built over it. When this doorway was moved from the south, its jambs of the doorway were cut back at the top so that the lower lintel could be accommodated in a narrower space. (The more prominent upper lintel, and the course of blocks to the left of it, were restored after excavation.) The lowest course of stone of the original mastaba was apparently left in place as a threshold. At right is 2097', with its southern false door (rg 23-6, 1989)

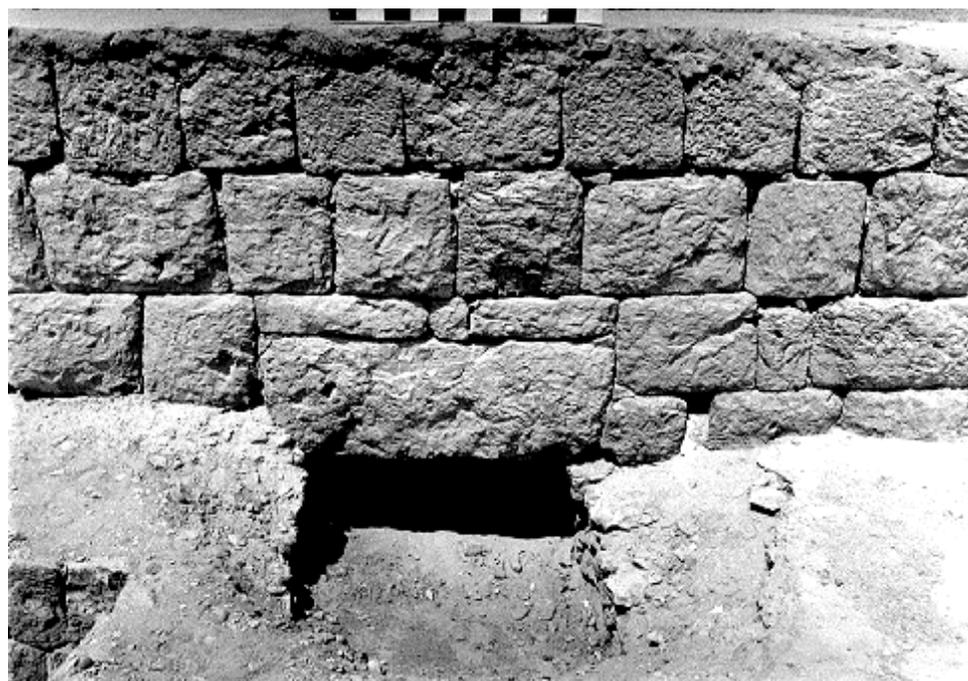
40c. 2091: northern entrance and, left of it, the north end of the corridor support wall built over 2089. At the lower left, 2098 abuts against 2089; the pyramid above is that of Khufu (rg 23-8, 1989)

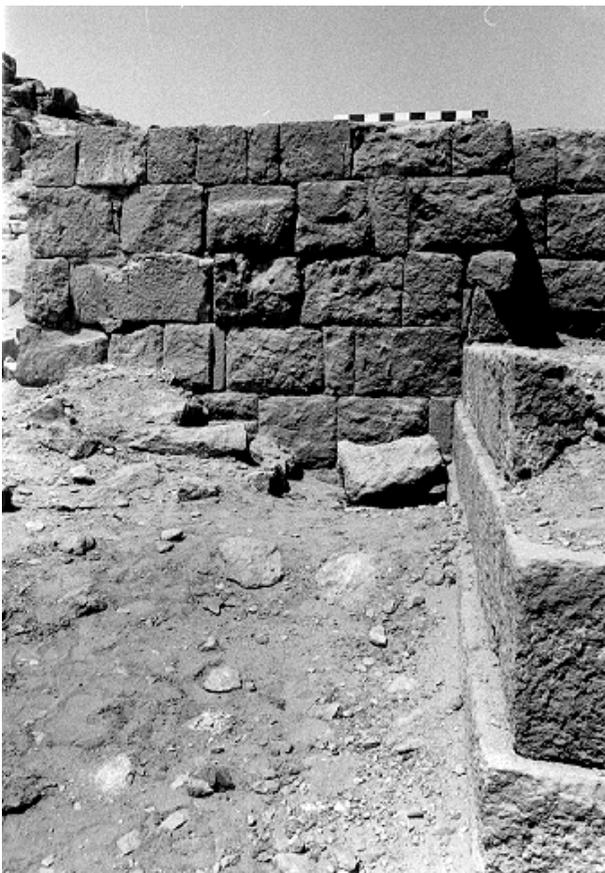
41c. 2091: eastern facade of the eastern extension, probably a blocked southern doorway. (The upper course, left of the photo scale, is restored.) That this extension was built against 2089 before it was reduced in height is demonstrated by the awkward way its right corner is supported where one of the stepped facade blocks has been removed. The contrast between the rough finish of the blocks in the central area, where the doorway would have been, and the smoother blocks to the left is also suggestive (rg 10-17, 1989)

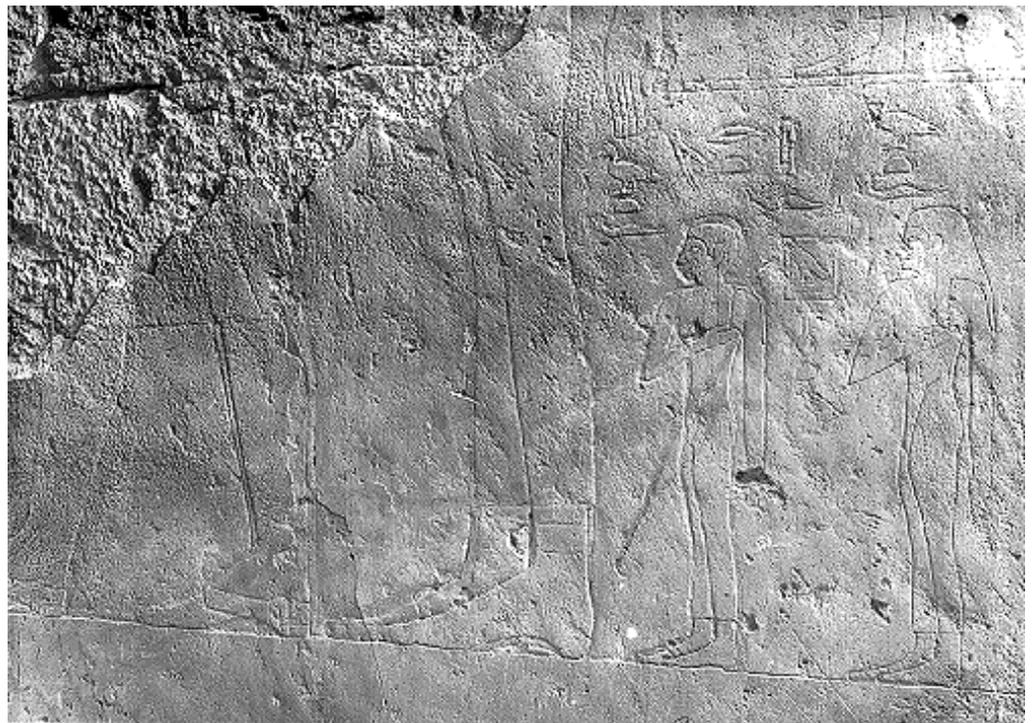
41d. 2091: east wall of the corridor, south end, showing the state of the figures of Kapi, Khamernernebt, and their three daughters soon after the mastaba's excavation by the Ballard expedition (1905-06) (Hearst Negative b 13012)

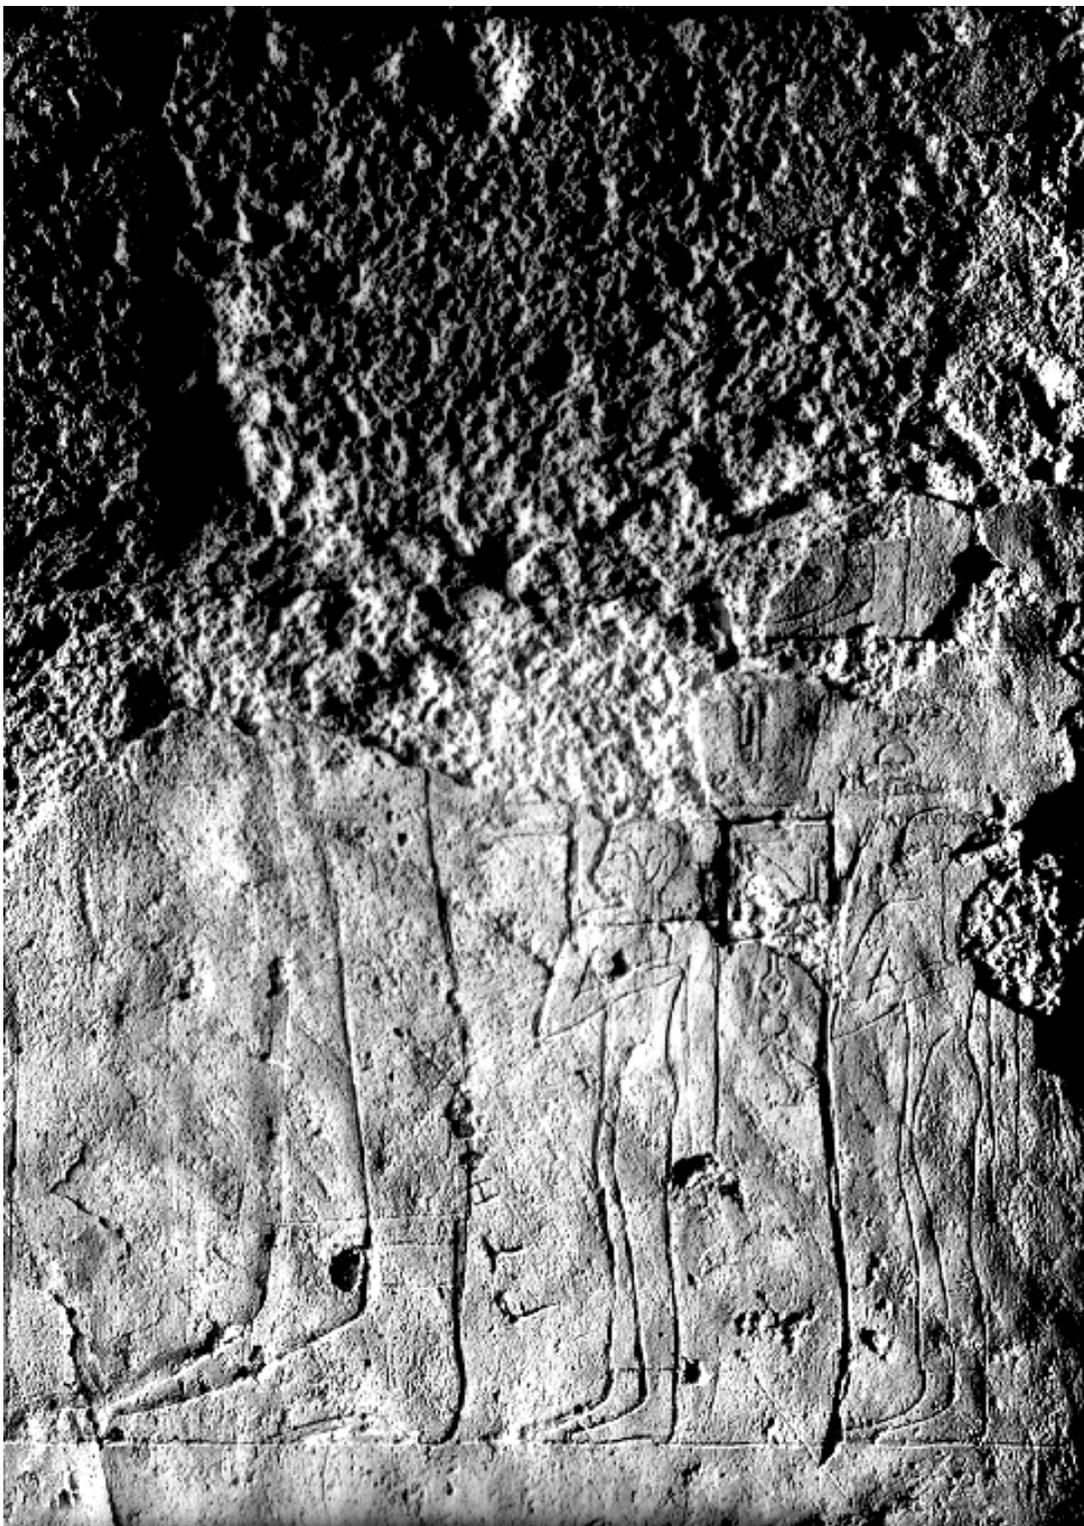
42a. 2091: east wall of the corridor, south end, showing the state of figures of Kapi and his family on March 28, 1931 (a 6457)

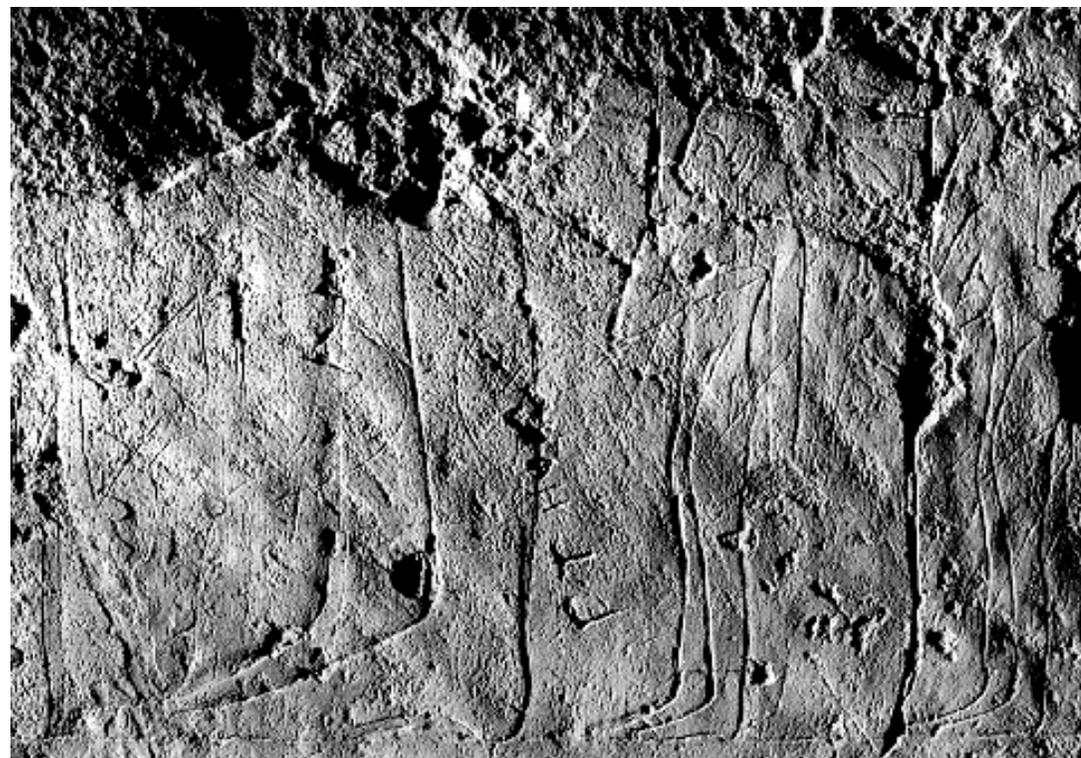
42b. 2091: east wall of the corridor, south end, showing the present state of Kapi and his family at the south end of the eastern corridor wall (rg 15-7, 1989)
