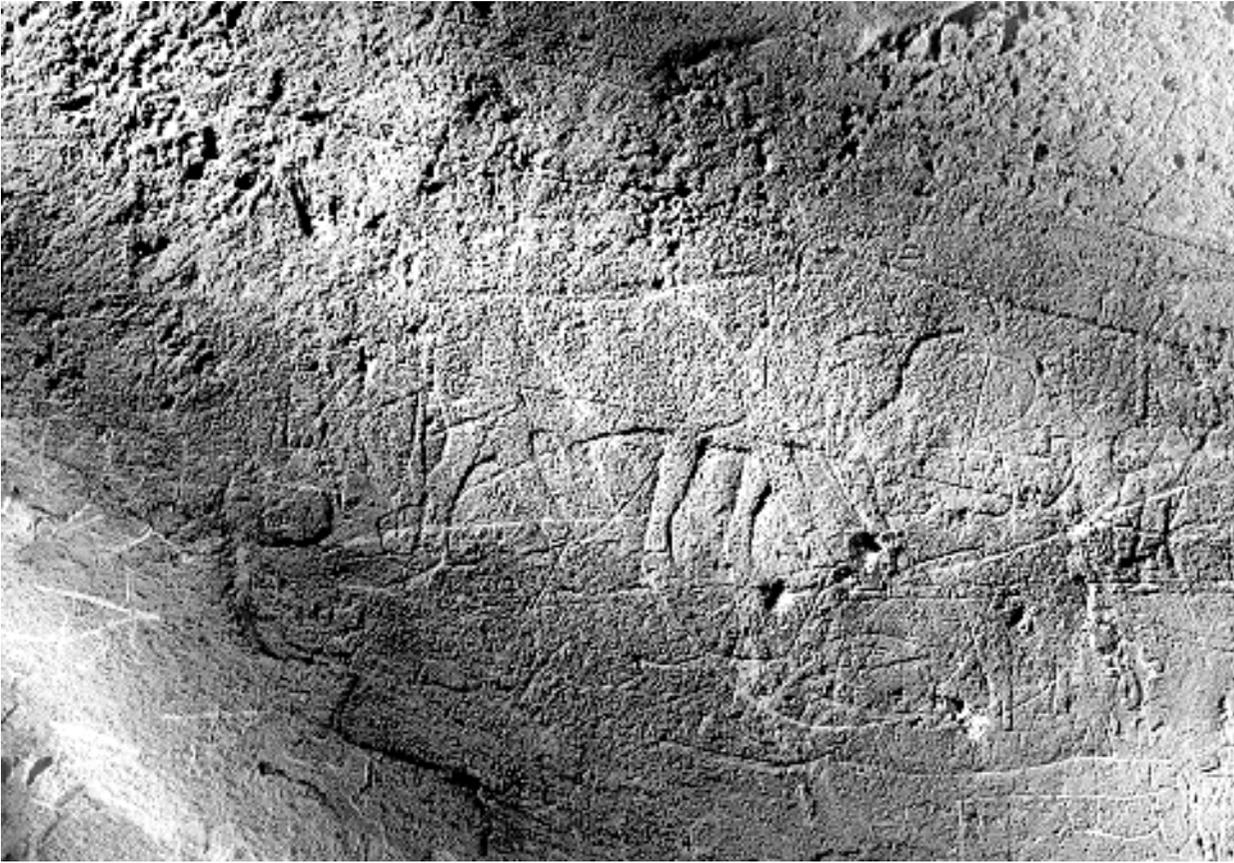
43a. 2091: west wall of corridor, showing the present state of the plaster-cut decoration, in which men are depicted driving cattle (rg 15-4, 1989)

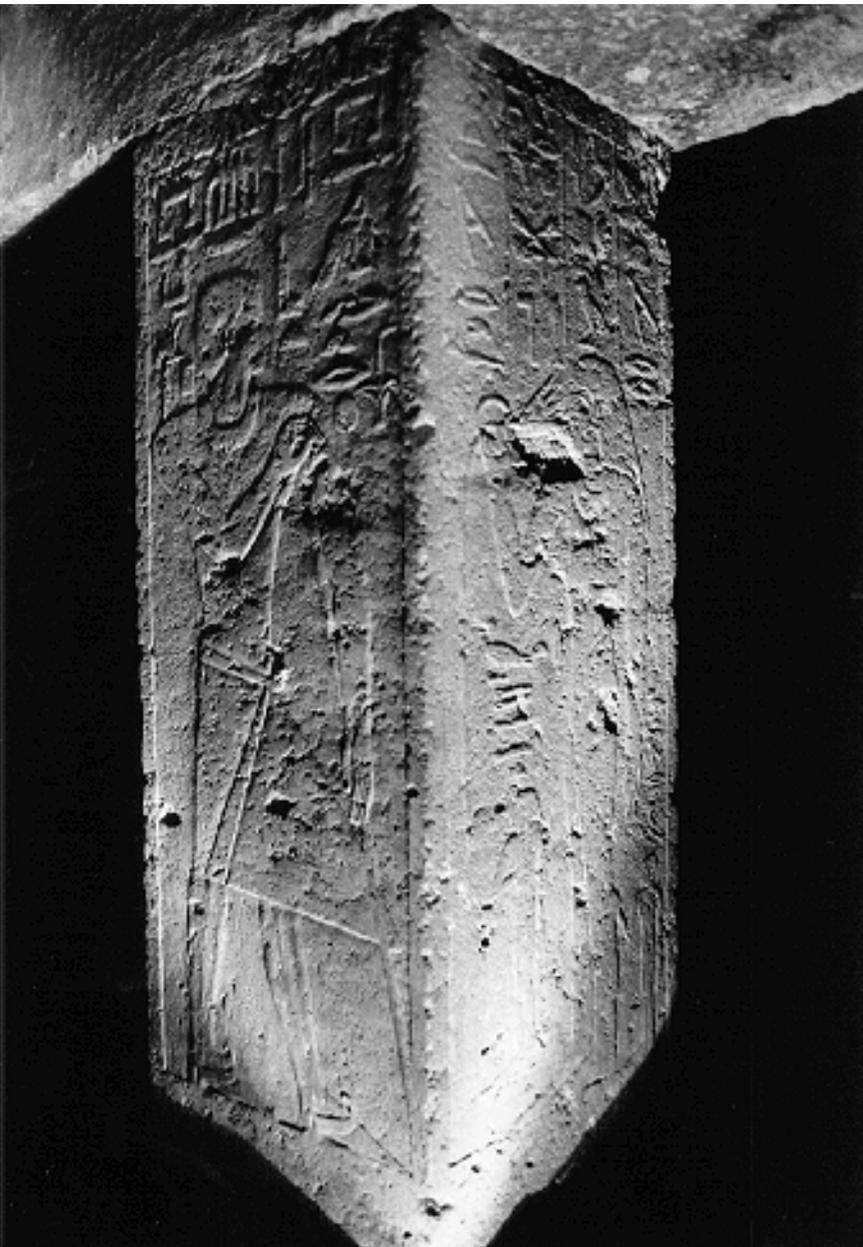
43b. 2091: east and north faces of the pillar, viewed from the south end of the entrance corridor. They depict Kapi (left) and his wife Khamerernebt (right). Although the orientation of the figures is conventional, away from the inner part of the chapel and towards the entrance, their comparative scales suggest that they were meant to be seen as a couple in a single scene, facing one another (rg 20-20)
